CONSERVATION OF MODERN  
ARCHITECTURAL HERITAGE: CASE  
STUDY OF SUMERBANK  
KAYSERI TEXTILE FACTORY  
EMPLOYEES' CLUB

A THESIS  
SUBMITTED TO THE DEPARTMENT OF ARCHITECTURE  
AND THE GRADUATE SCHOOL OF ENGINEERING AND  
SCIENCE OF ABDULLAH GUL UNIVERSITY  
IN PARTIAL FULFILLMENT OF THE REQUIREMENTS  
FOR THE DEGREE OF  
MASTER OF SCIENCE

By  
İrem BAZ  
April 2023

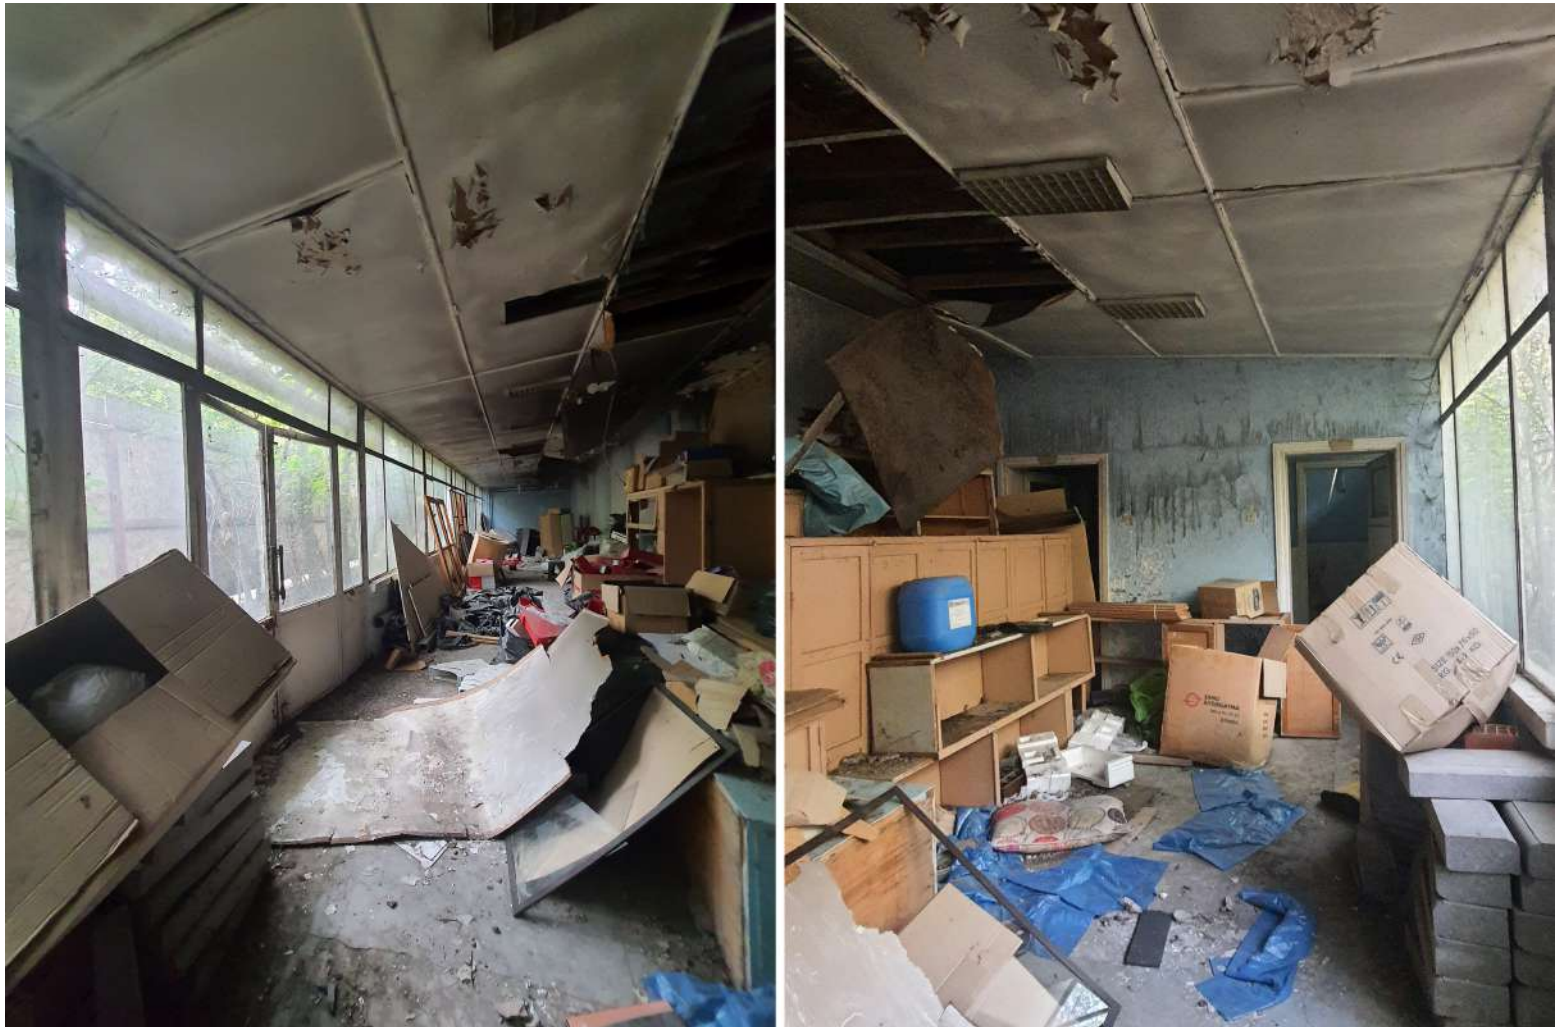
**Figure 4.1 G01 foyer**

Although there was not much damage in this place, paint spillage and surface deposit were detected on some walls. In addition, some parts of the ceiling covering were damaged (Figure 4.1).

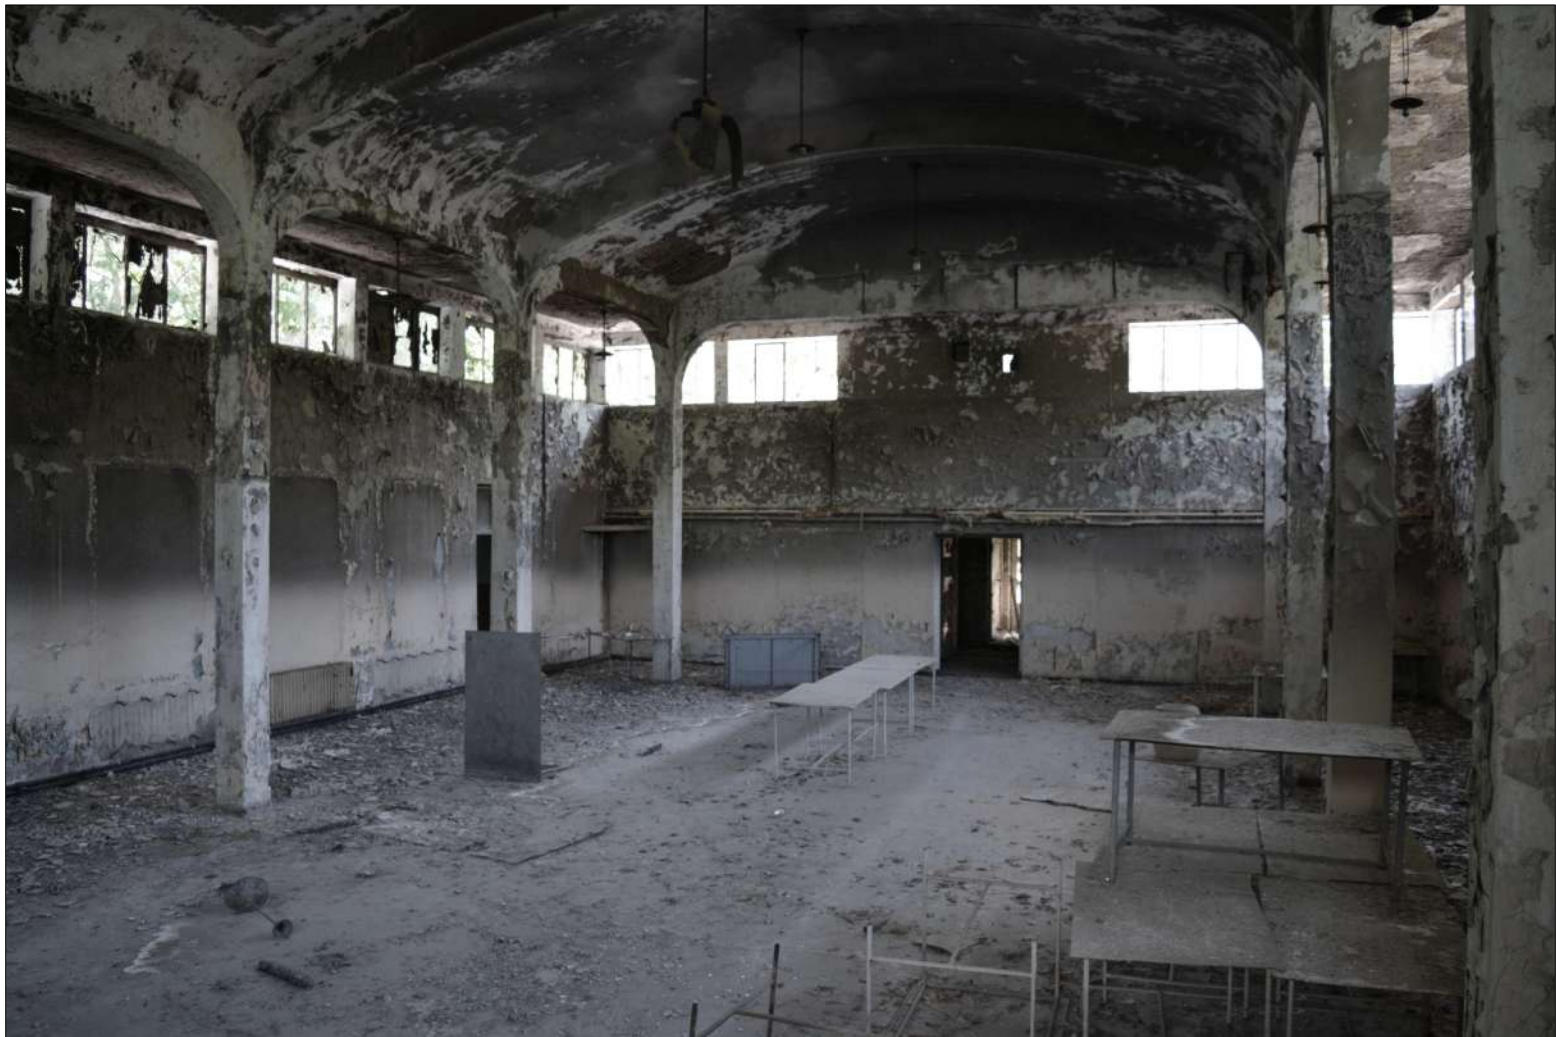
**Figure 4.2 G02 cinema hall**

The whitewash and plaster of the walls of this place have been peeled off. Because the roof of the whole space is reinforced concrete with only insulation pitch, the ceiling leaks water from the roof. The inclination is observed in the axes of some columns. Architectural elements were damaged due to the fire that broke out in the

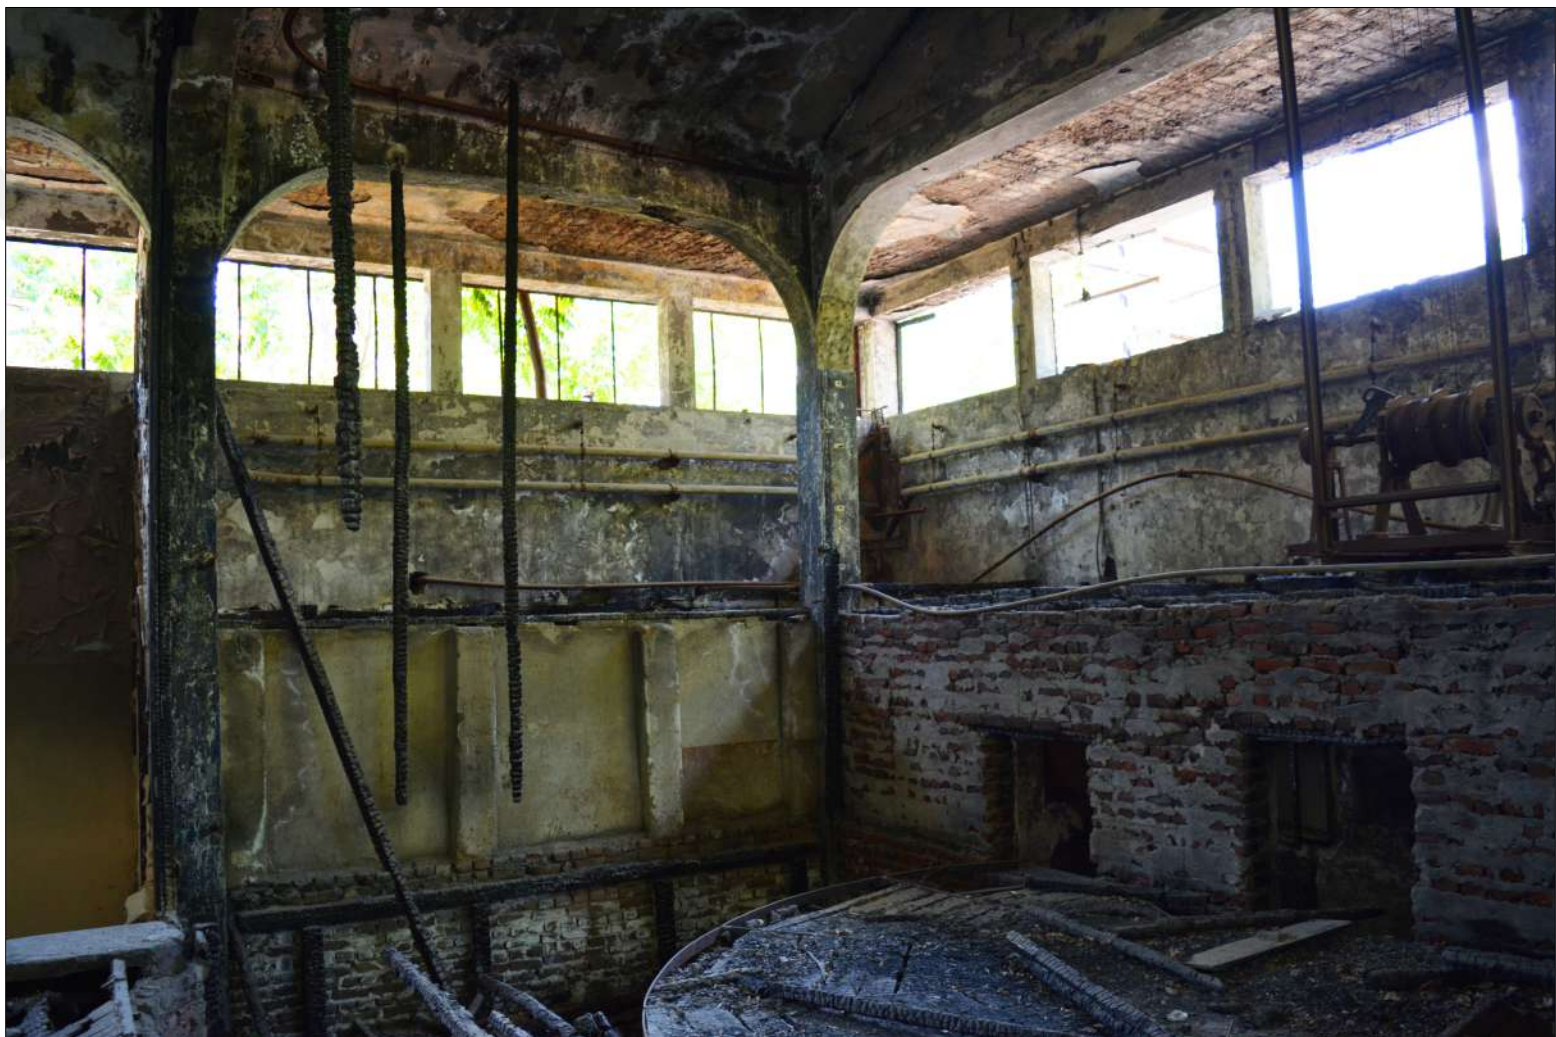
**Figure 4.3 Stage of the cinema hall**

north of the space in 2007 (Figure 4.3). Since the ceiling of the place receives water from the roof, the surface is worn, and the reinforcements are visible and corroded.

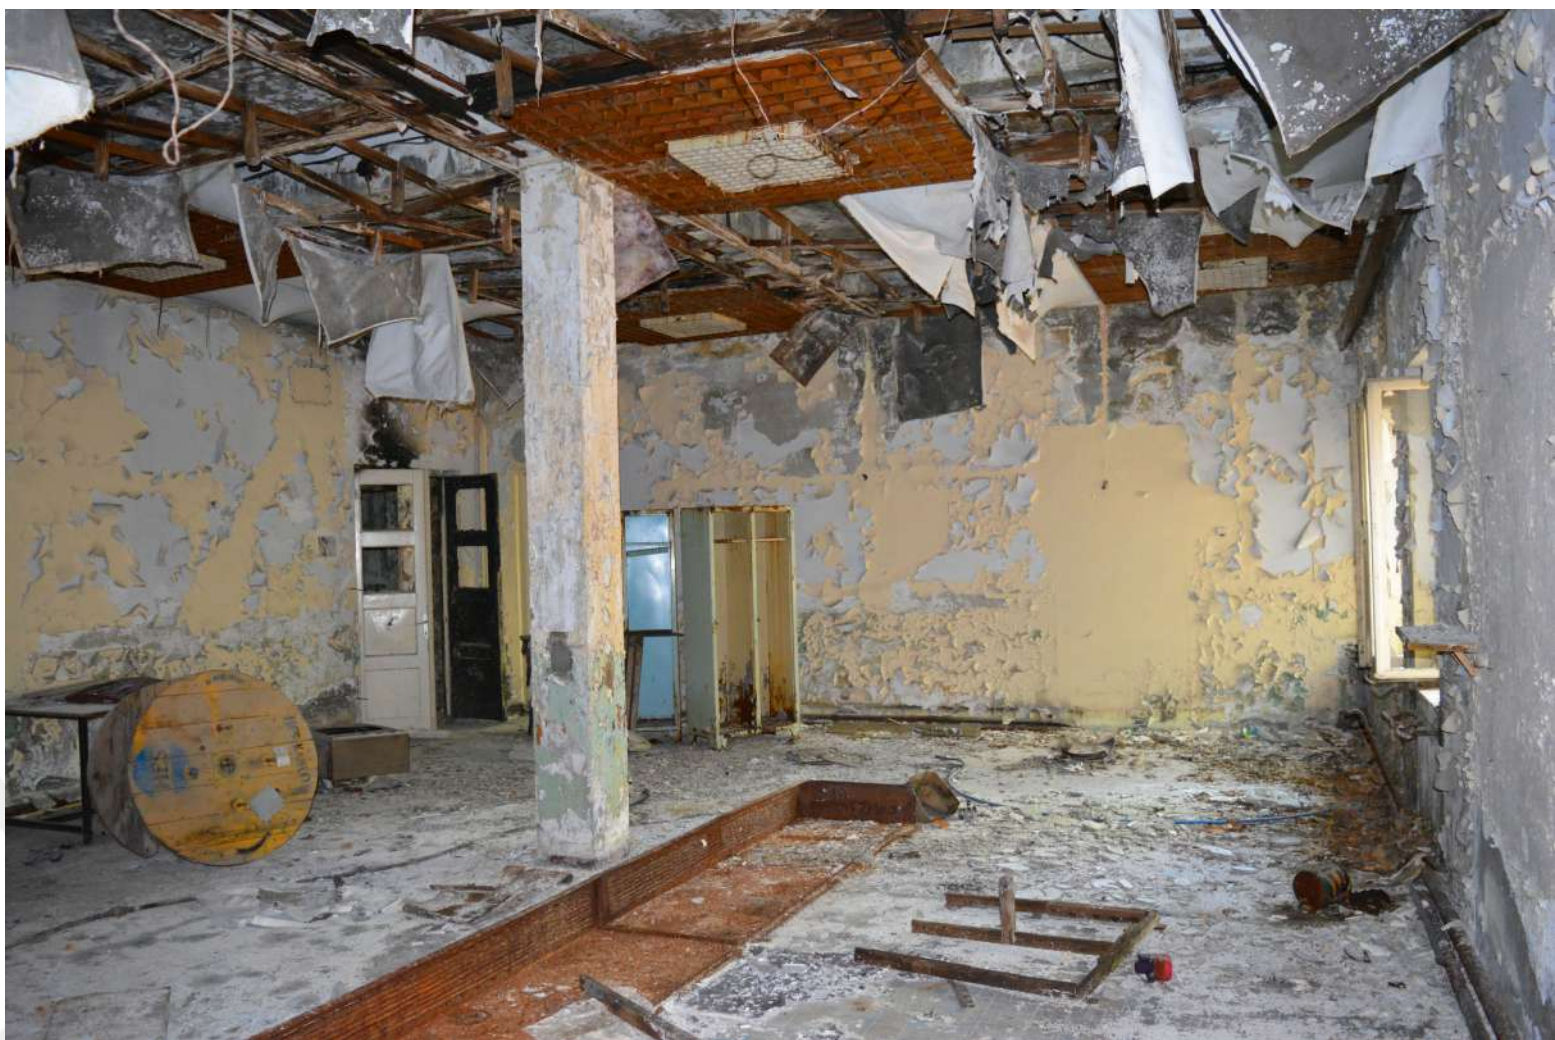
**Figure 4.5 G05 space**

building (Figure 4.5). It measures 7.5m x 14m. The ceiling height is approximately 3.8 meters. In the middle of the space, there are two reinforced concrete columns. The floor is ceramic, and the ceiling is wooden suspended ceiling<sup>13</sup>. The wood is used in drop-shaped modules, and each module is wrapped with a white fabric. Between these modules, a grid wooden system and lighting elements are placed at regular intervals. There is a wooden door (D16) to the east of the place. On the north, there is a small kitchen protruding from the façade as well as six wooden windows. To its west is the door (D17) that opens to the G07. There is no serious damage to this space but the suspended ceiling. The whitewash on the walls has peeled off.

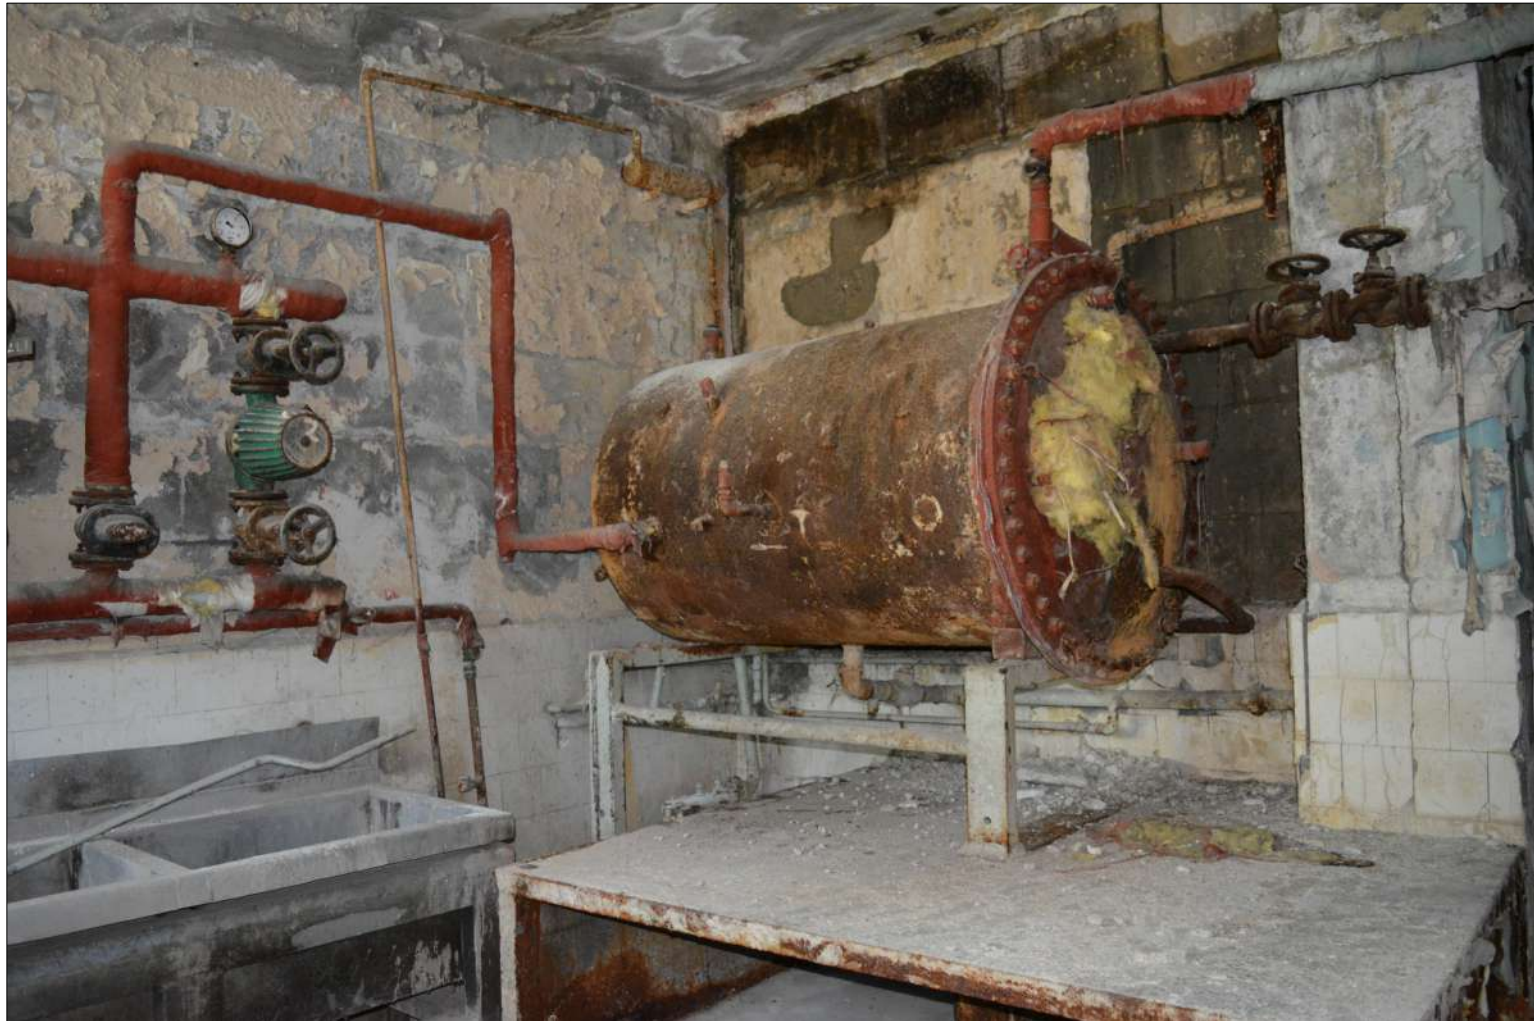
**Figure 4.11 Water tank of the kitchen**

A two-compartment cellar and a dish rack are located in the west. The cellar part has a separate door and there is also a room for the cold storage. A water unit is hung for hot water use in this area (Figure 4.11). There is a door in the south of the place, but the door leaf is missing. Reinforced concrete beams can be clearly read on the ceiling. The paint on the walls has been stripped. Particularly on the western wall, material loss is observed. There is damage to both the walls and the ceiling due to the water leaks

from the roof. Iron reinforcements were exposed on the ceiling, and these are corroded.<sup>15</sup>

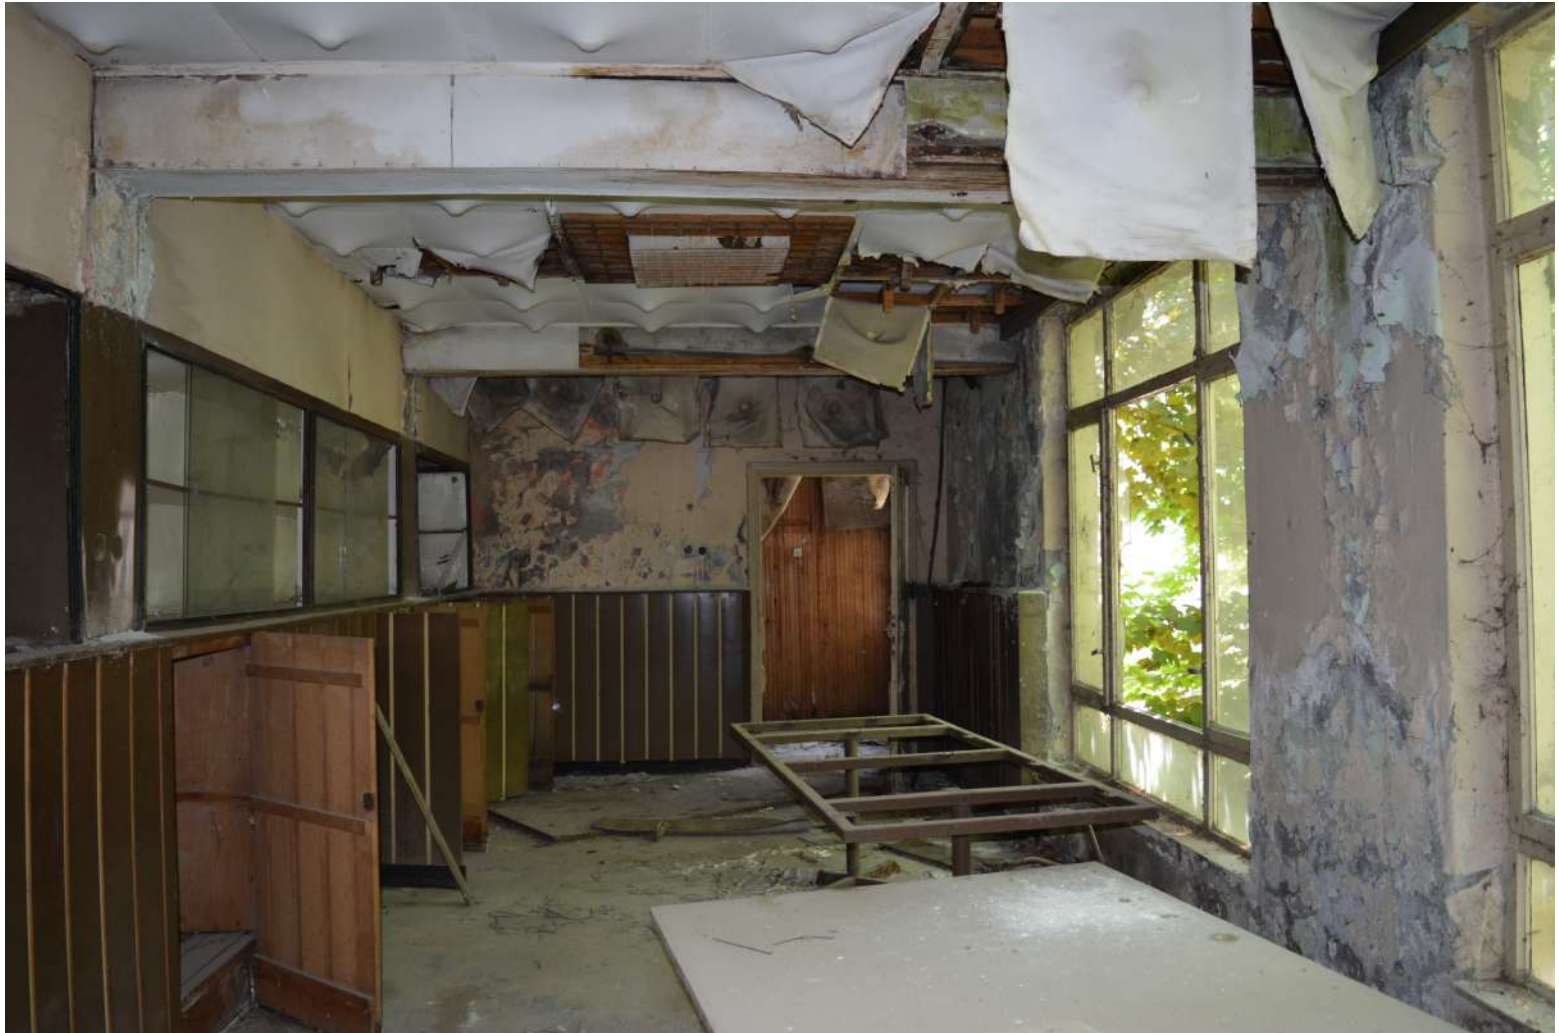
**Figure 4.15 G14 space**

The cabinets and wooden lining on the north wall of the room were damaged. Since a part of the wall is covered with panels, an opening has occurred in the damaged part and the club part can be seen from there. As it can be understood from that opening, its own structure system was designed while adding this space. Lastly, only part of the wooden suspended ceiling is damaged.

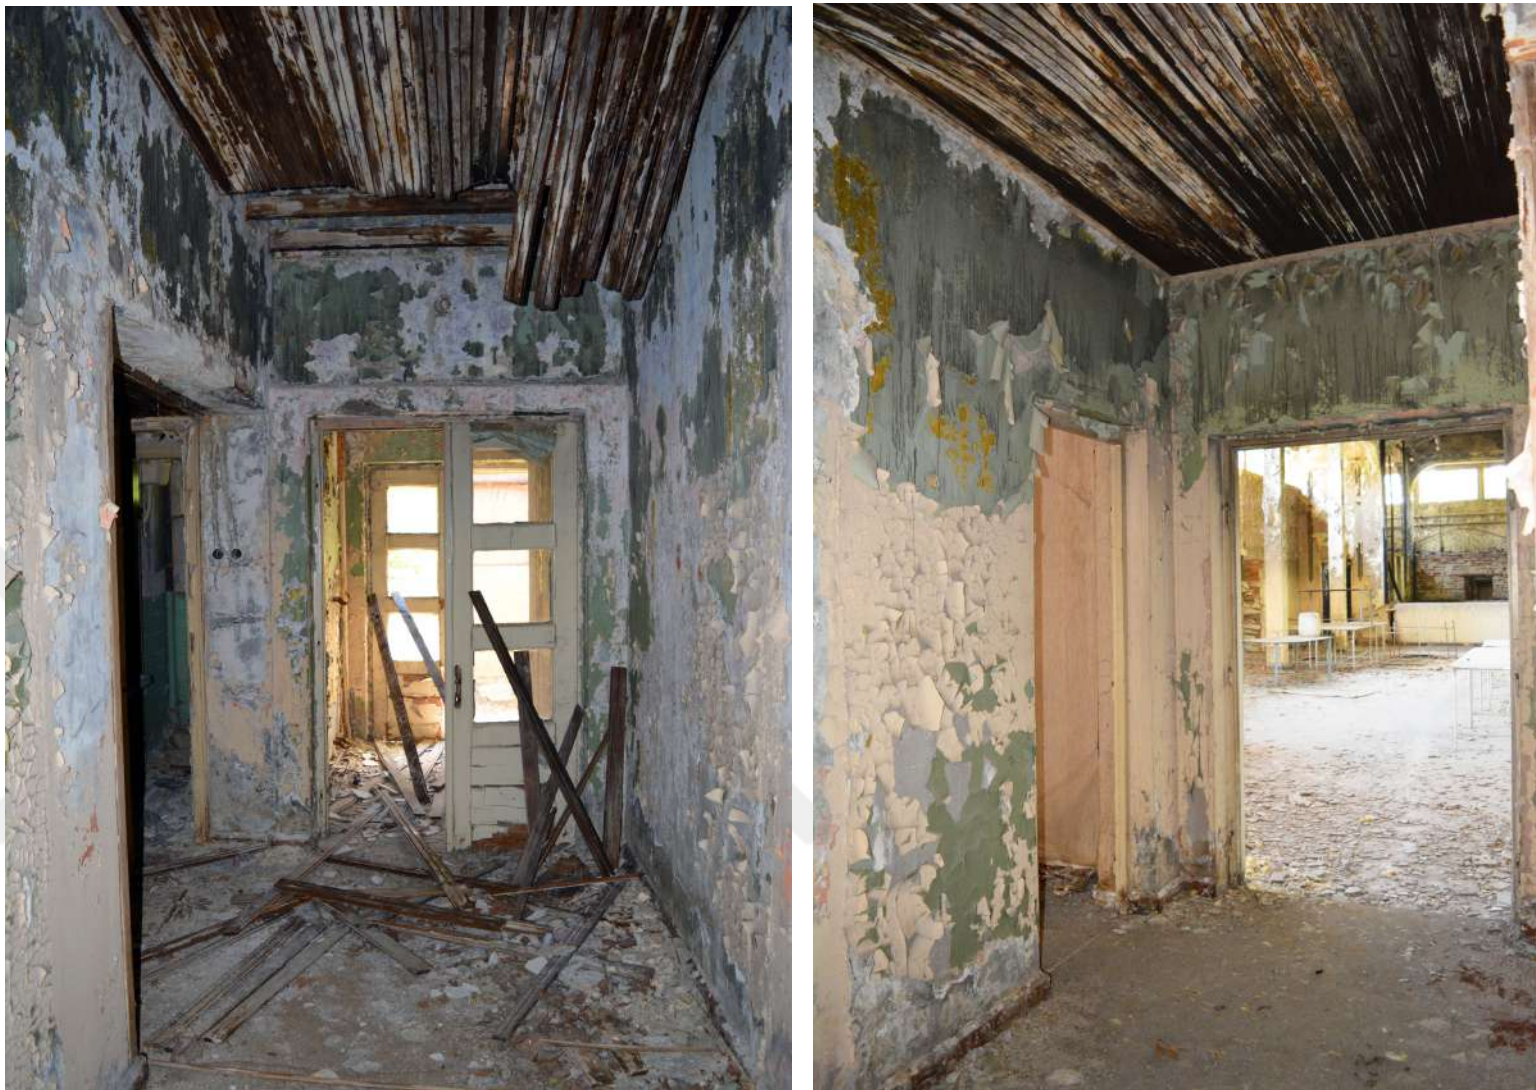
**Figure 4.19 G18 space**

The space leaks water from the roof. For this reason, damages such as corrosion of reinforcements and vegetation were observed on the ceiling. At the same time, most of the wooden suspended ceiling was damaged. Its floor is covered with rubble due to elements pouring from the ceiling.

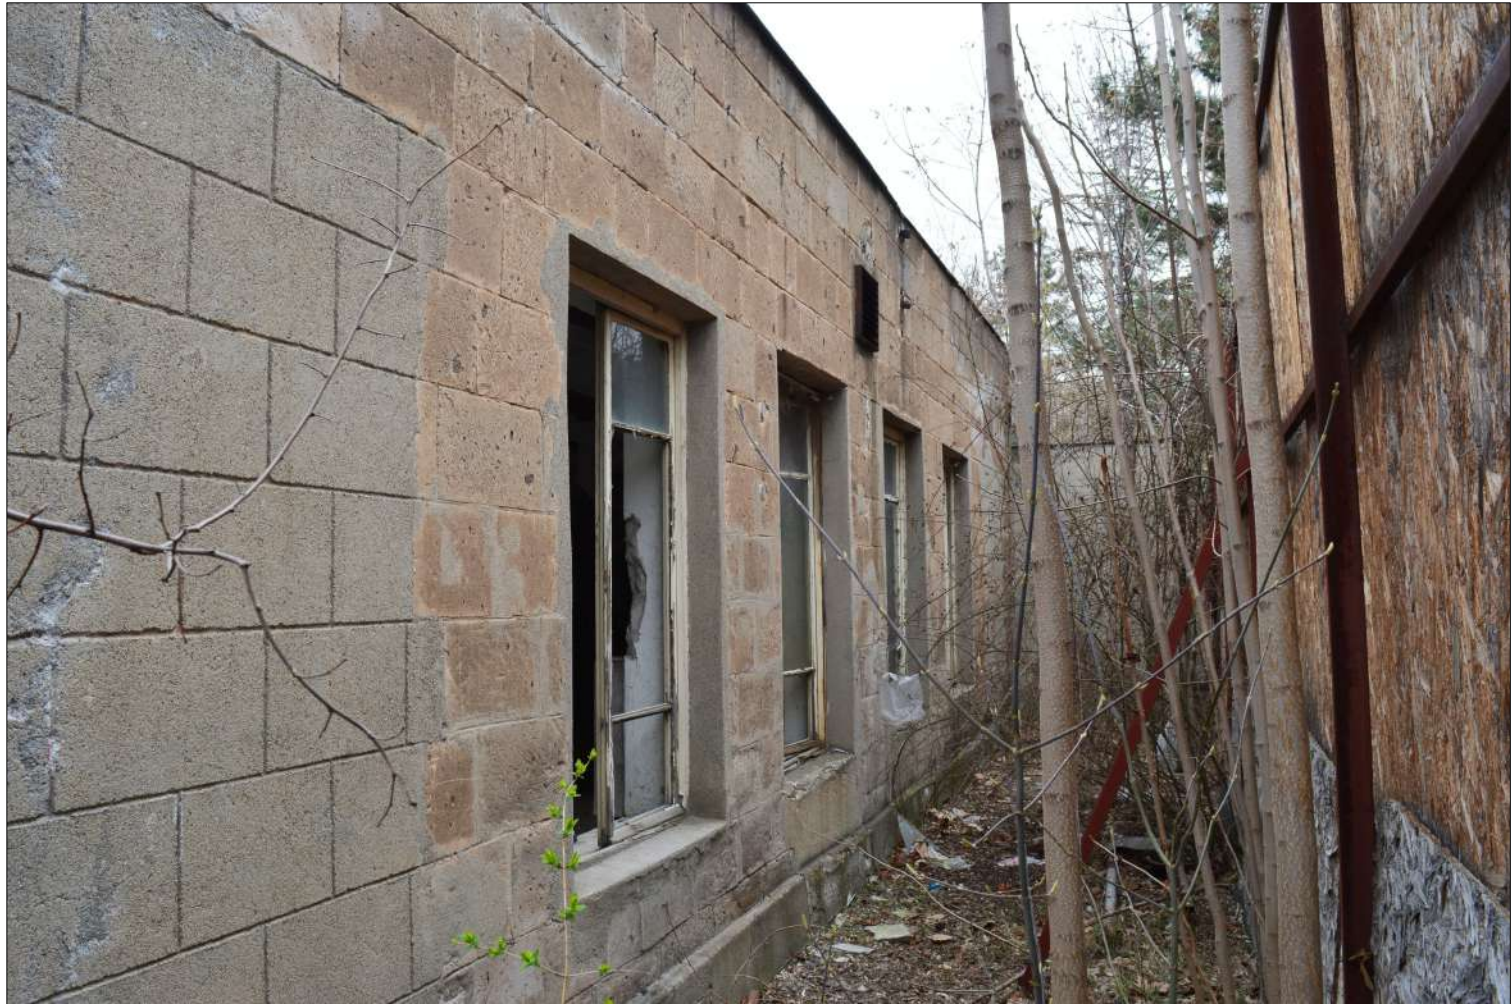
All the façade elements are cladding stones. On the other hand, the northern and southern ends of the protruding section were added later and are plaster with a stone look. The southern section of the façade ends with an iron railing 50cm high (Figure 4.26). In particular, there are trees adjacent to the façade. The roots of these trees have damaged the façade stones.

**Figure 4.25 View of the protruding section of the western façade**

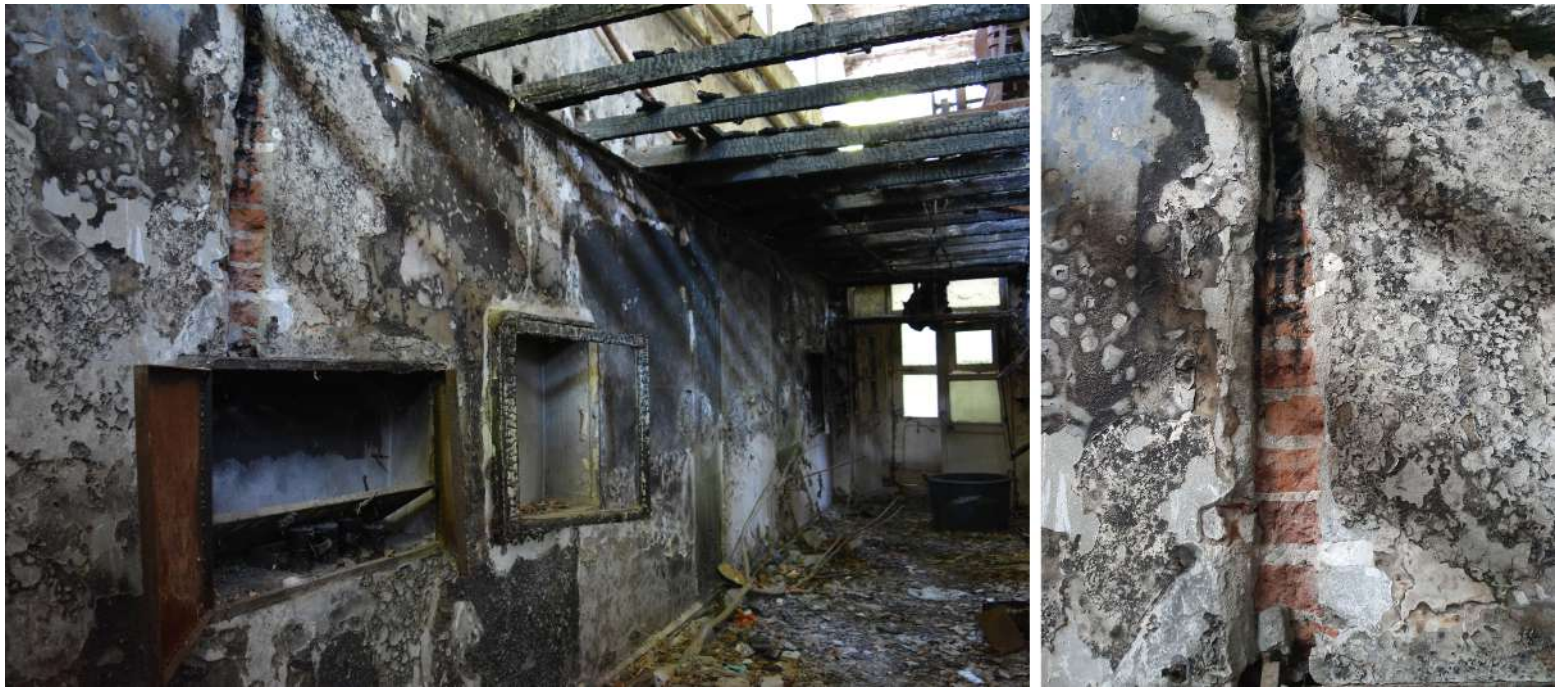
Mixed use of materials is observed in the Employees' Club. The building has a framed structure built with reinforced concrete. The industrial brick measuring 20cm x 10cm x 5cm is widely used in the walls (Figure 4.34). The façade cladding is Kayseri tuff. The dressing stones are measuring approximately 30cm x 55cm. Interior surfaces are cement plastered and whitewashed. According to the function of the spaces, some surfaces are covered with ceramics like in the kitchen, the east wall of the club, and the toilets.

**Figure 4.34 Brickwork of the wall is visible from under the plaster.**

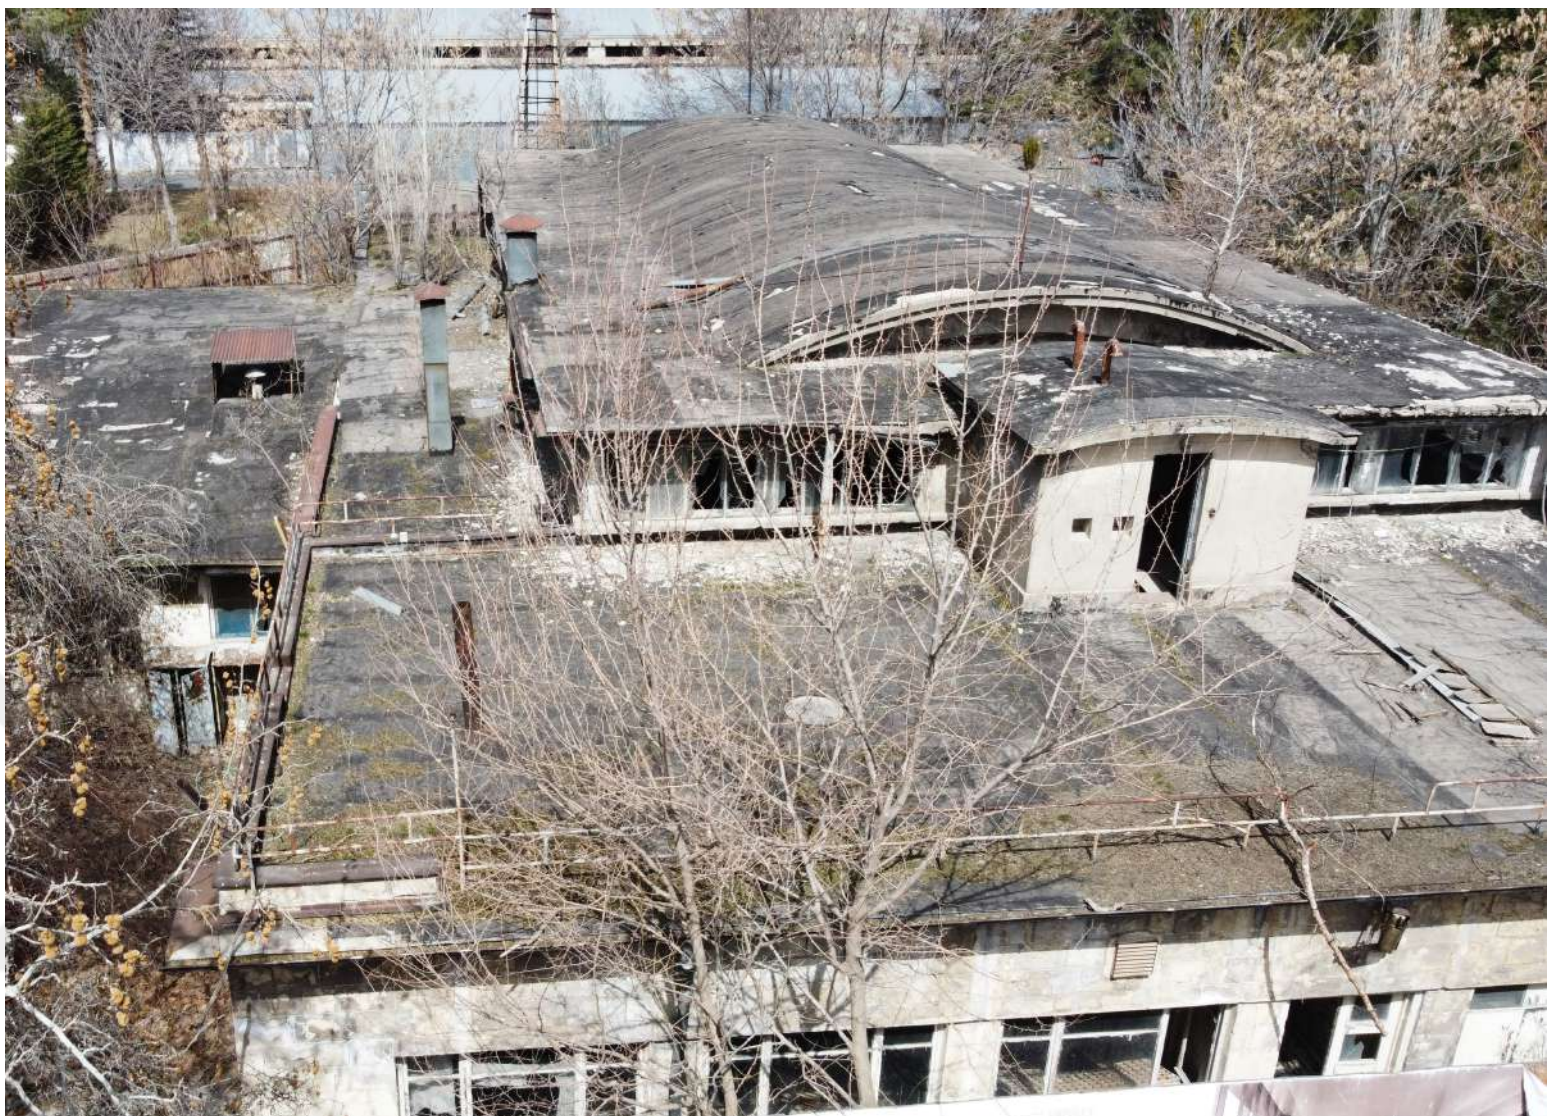
**Figure 4.35 View of the roof**

The roof of the Employees' Club building is reinforced concrete. Only insulation pitch has been applied on the roof, so it is not resistant to weather conditions. Flat roof, vaulted roof, and porch roof systems were used in the roof system of the building. The roof of the cinema hall (G02) and the corridor (G03) have a vault system. The porch roof is used only in the foyer (G01). Lastly, the other spaces have a flat roof system. The roof is surrounded by rain gutters and vertical pipes connected to them.

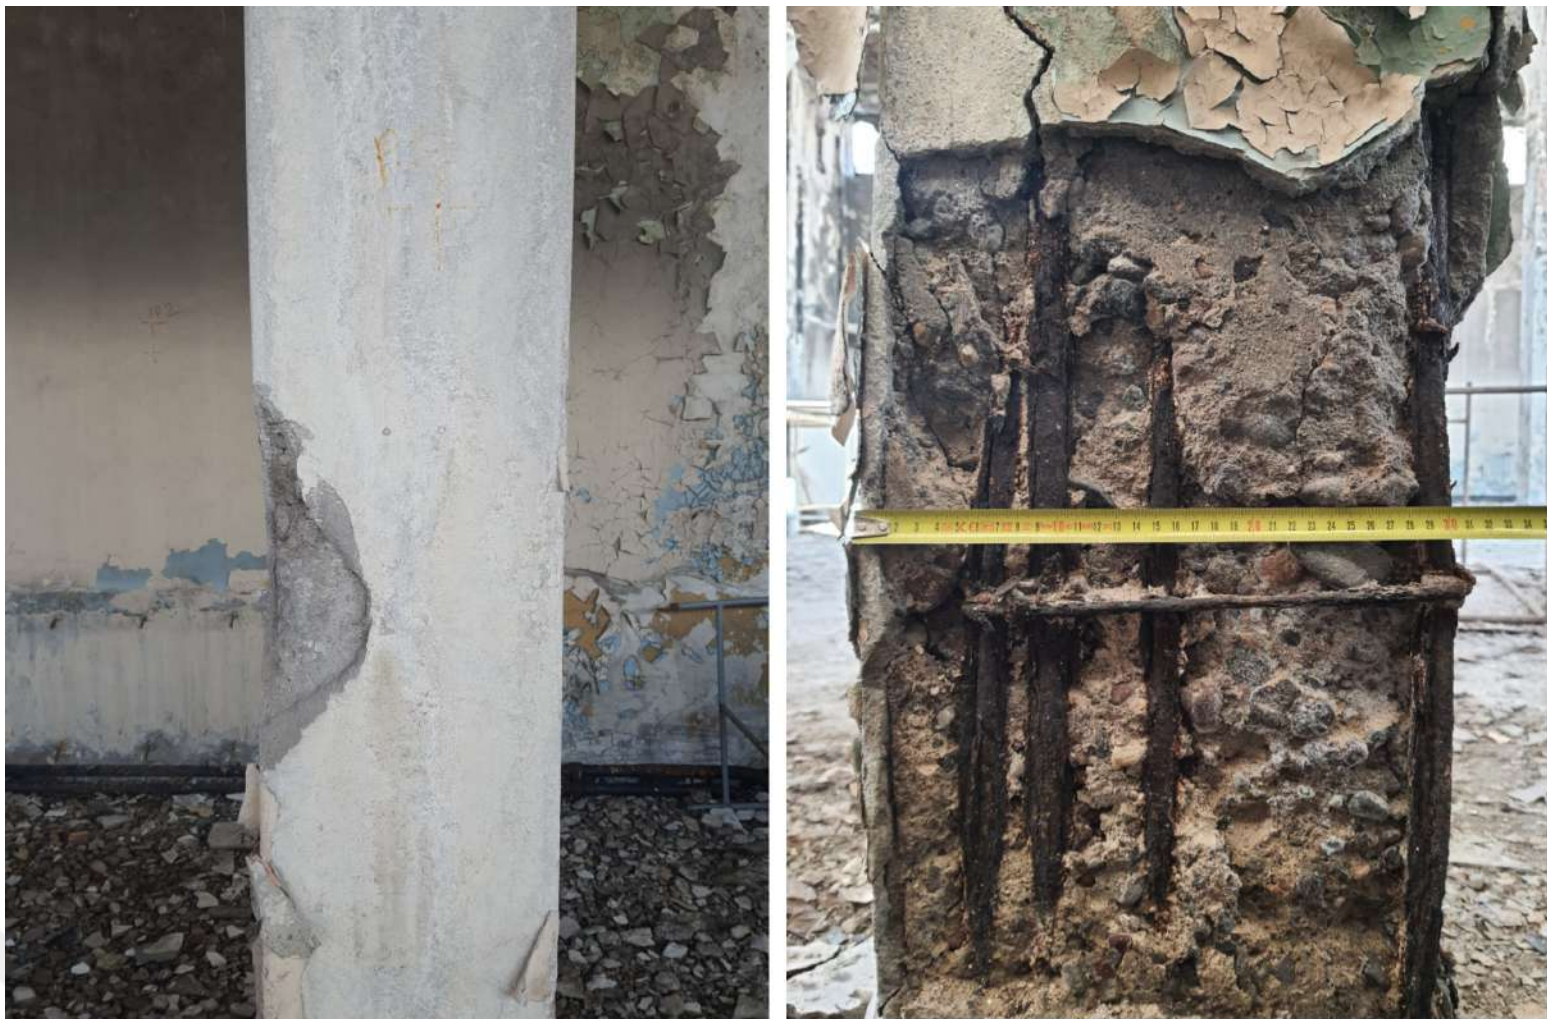
There are some structural problems in the building. Some declination has been detected in certain column axes in the cinema hall. It has shifted about 12cm north from the ground. Whether these declinations are caused by a damage to the connection of the column with the foundation will be understood by removing the slab. The water leakage at the roof can be also the reason for this structural problem indirectly.

**Figure 4.36 Structural decay of the columns in the cinema hall**

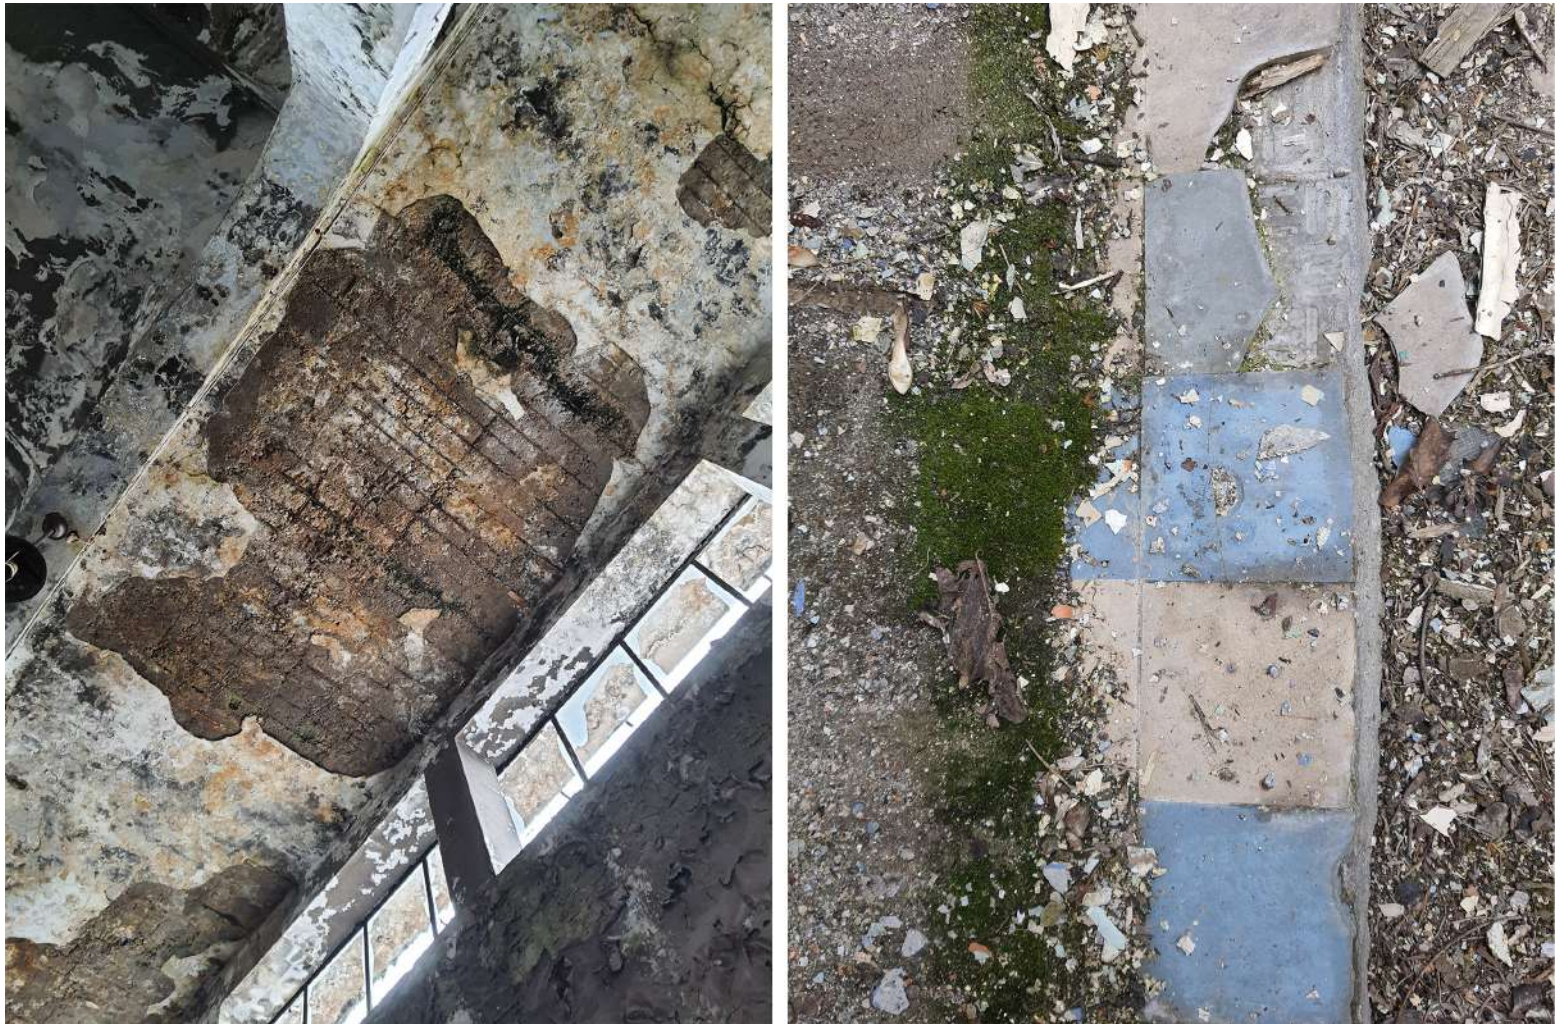
**Figure 4.37 Material decay**

The brickwork of the wall is visible as a result of plaster pouring on this part where the gutter meets the ground. Salt efflorescence and surface deposits are mostly observed throughout this façade. Moss and flowering are observed especially in the eastern façade and the northern façade, close to the ground. It is observed that the material used for waterproofing on flat roofs and vaulted roofs wears out over time. As can be seen from the aerial photographs, some cracks were also detected on the roof. Small trees appeared in most parts of the roof material. There have been also surface losses in reinforced concrete edges.
