CONSERVATION OF MODERN  
ARCHITECTURAL HERITAGE: CASE  
STUDY OF SUMERBANK  
KAYSERI TEXTILE FACTORY  
EMPLOYEES' CLUB

A THESIS  
SUBMITTED TO THE DEPARTMENT OF ARCHITECTURE  
AND THE GRADUATE SCHOOL OF ENGINEERING AND  
SCIENCE OF ABDULLAH GUL UNIVERSITY  
IN PARTIAL FULFILLMENT OF THE REQUIREMENTS  
FOR THE DEGREE OF  
MASTER OF SCIENCE

By  
İrem BAZ  
April 2023

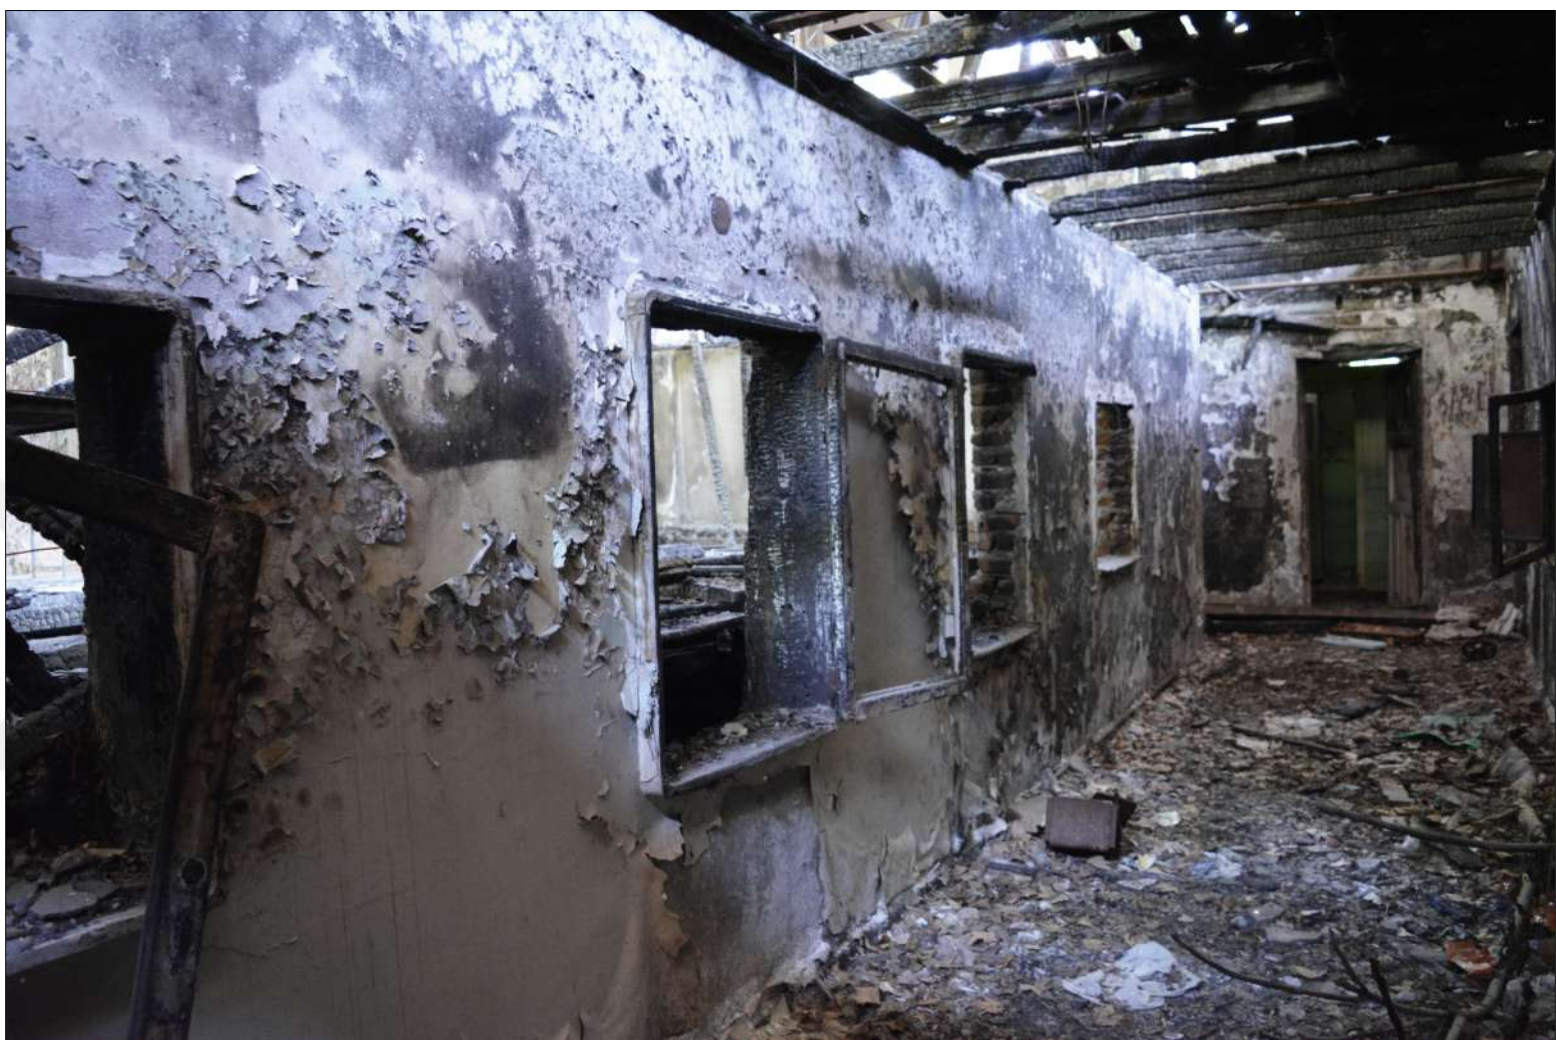
**Figure 4.4 G03 corridor**

In the old drawings, it is known that there were two doors in the north of the space, providing access to the backstage. The flap of the other door (D11) is not in place. From this door, there is the corridor (G03) that provides access to the places behind the stage (Figure 4.4). The corridor is also connected to the other entrance on the east side of the building<sup>12</sup>. However, the other door to the east of the stage was later closed. The walls are plastered and whitewashed, and blue ceramics are used in its flooring. There are four windows on the wall of stage. The burnt wooden skeleton is read on the ceiling. Above the wooden frame, the iron machine which was controlling the stage curtain is still present in the same place. To the east of the stage is the space (G04), which is thought to have been used for stage needs. Its entrance is provided by this corridor. The east and south walls of the space are blind walls, but the trace of the old door can be read on the south. Since this place was also affected by the fire, the western wall and ceiling are almost lost.

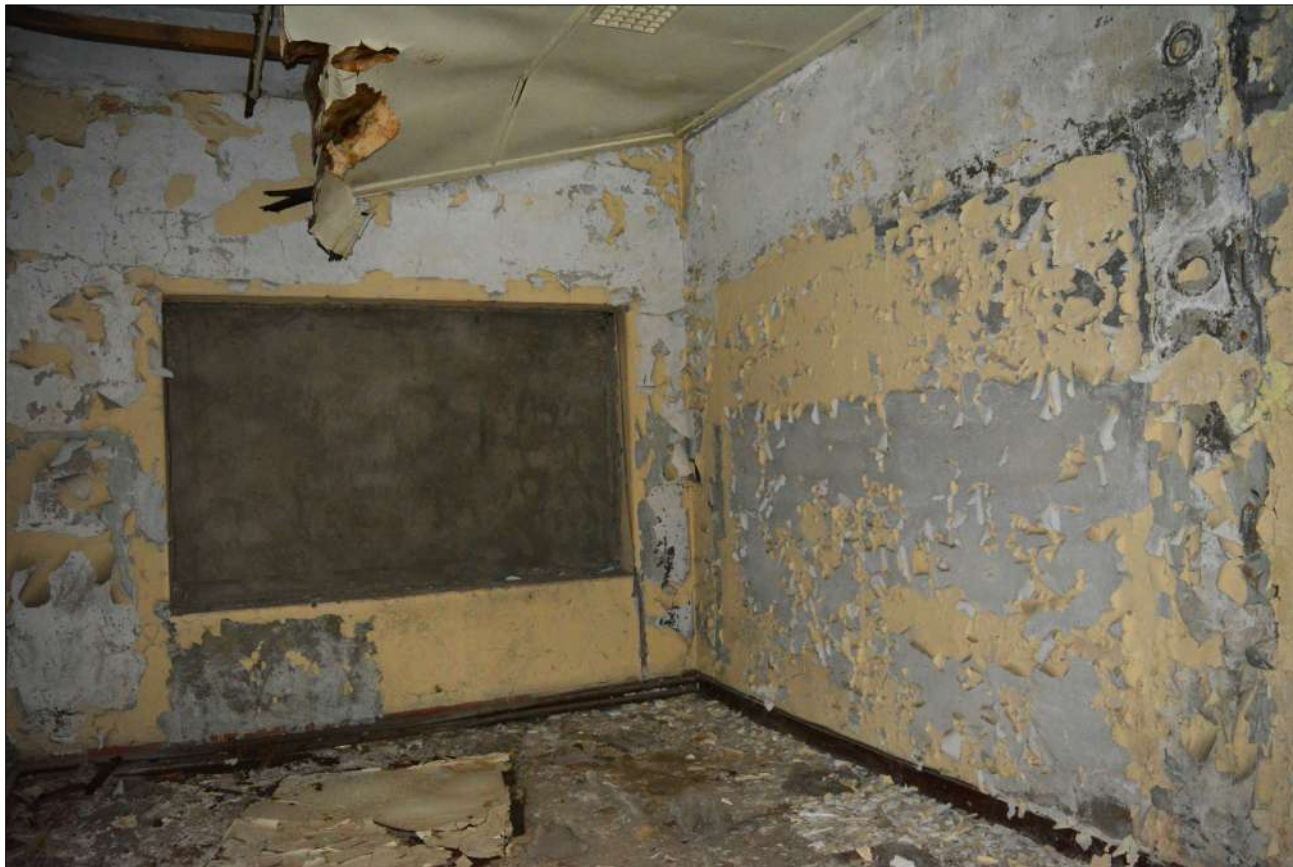
**Figure 4.6 G06 space**

G06 is located east of the game room. The floor is concrete, the walls are plastered and whitewashed (Figure 4.6). It measures 3.7m x 7.7m and is 3.7m high. Wood paneling was used on its ceiling, but most of the wood pieces were damaged and fell off. There are two windows on the north façade. The eastern wall is a blind wall. There is a 2.5m long niche on the south wall. It is thought that there was an opening in this wall before and it was closed afterward.

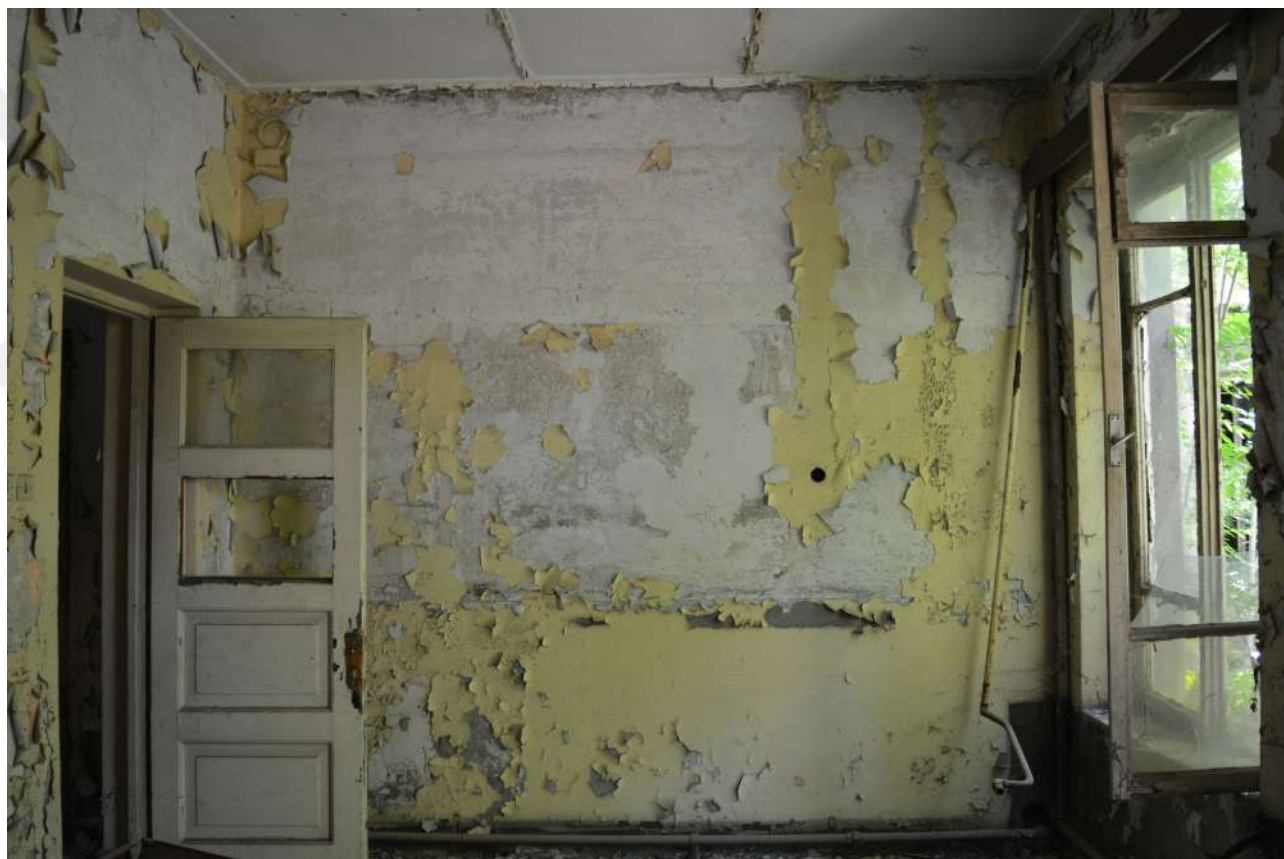
**Figure 4.7 G07 space**

On the west of the game room, there is another space (G07). It measures 3.7m x 5.5m and is 3.5m high. The floor is concrete screed. The east, north, and south wall is a blind wall. There are two wooden windows on the west side. There is not any serious damage in this space. Only the whitewashed has peeled off and a small part of the ceiling is damaged (Figure 4.7).

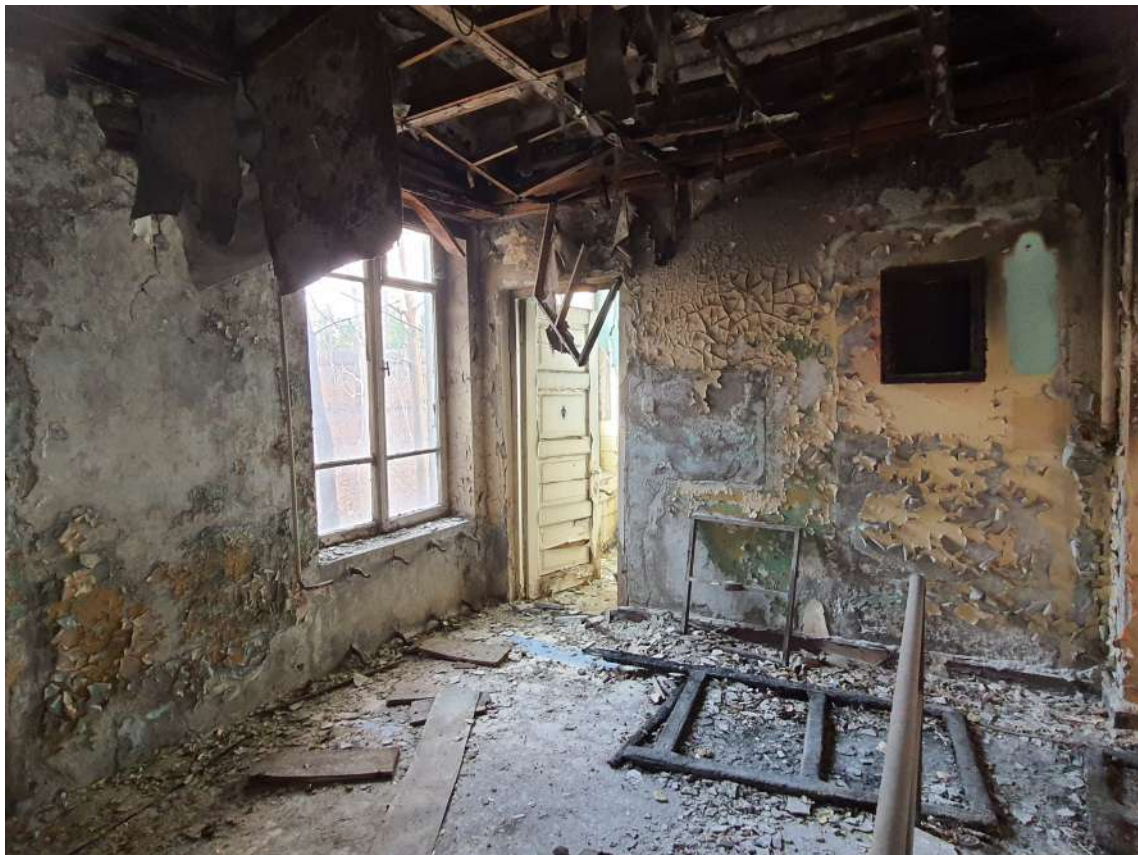
**Figure 4.9 G09 space**

The space (G09) connecting the backstage and the club part measures approximately 3.5m x 4m. The height of the space is 3.8m without the suspended wooden ceiling. Ceramic is used for the flooring. The ceiling is wooden suspended ceiling that we see in other places. There is an opening on the east wall. To the north is the women's toilet. There is a window on the west and a double-winged door (D23) opening to the club. On the south wall there is a small opening for food service and a

metal bench in front of it (Figure 4.9). The whitewash and some parts of the plaster on the walls have been peeled off. The wooden suspended ceiling is in a dilapidated state<sup>14</sup>.

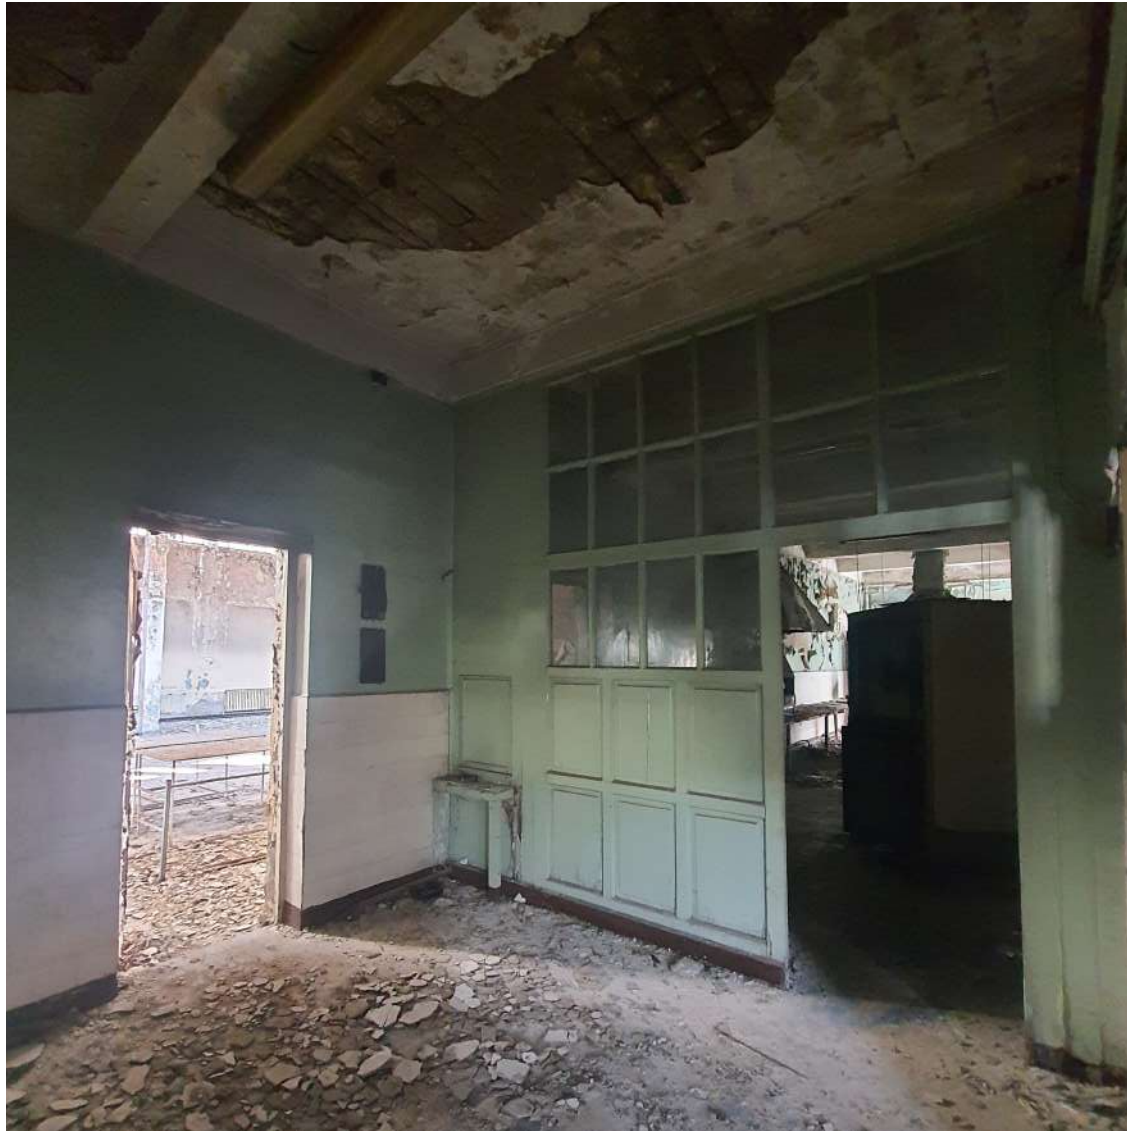
**Figure 4.10 G10 space**

There is another transition space (G10) connecting the stage (G02) and the club (G13). This place also measures 3.6m x 3.7m. The floor is ceramic coated, the ceiling is reinforced concrete. To the east is a wooden single-wing door (D10). There is a small service window to the north and a metal bench in front of it. Part of the north wall has white ceramic tiles (Figure 4.10).

The western part of the space is a more permeable surface. There is a wooden door that connects the club and windows that work like a partition. In the south part, there is a wooden surface and a door separating the kitchen (G11) from this space. The whitewash on the north wall has been completely stripped. The ceramics on the wall were broken. Material loss is observed on the western wall, especially around the door.

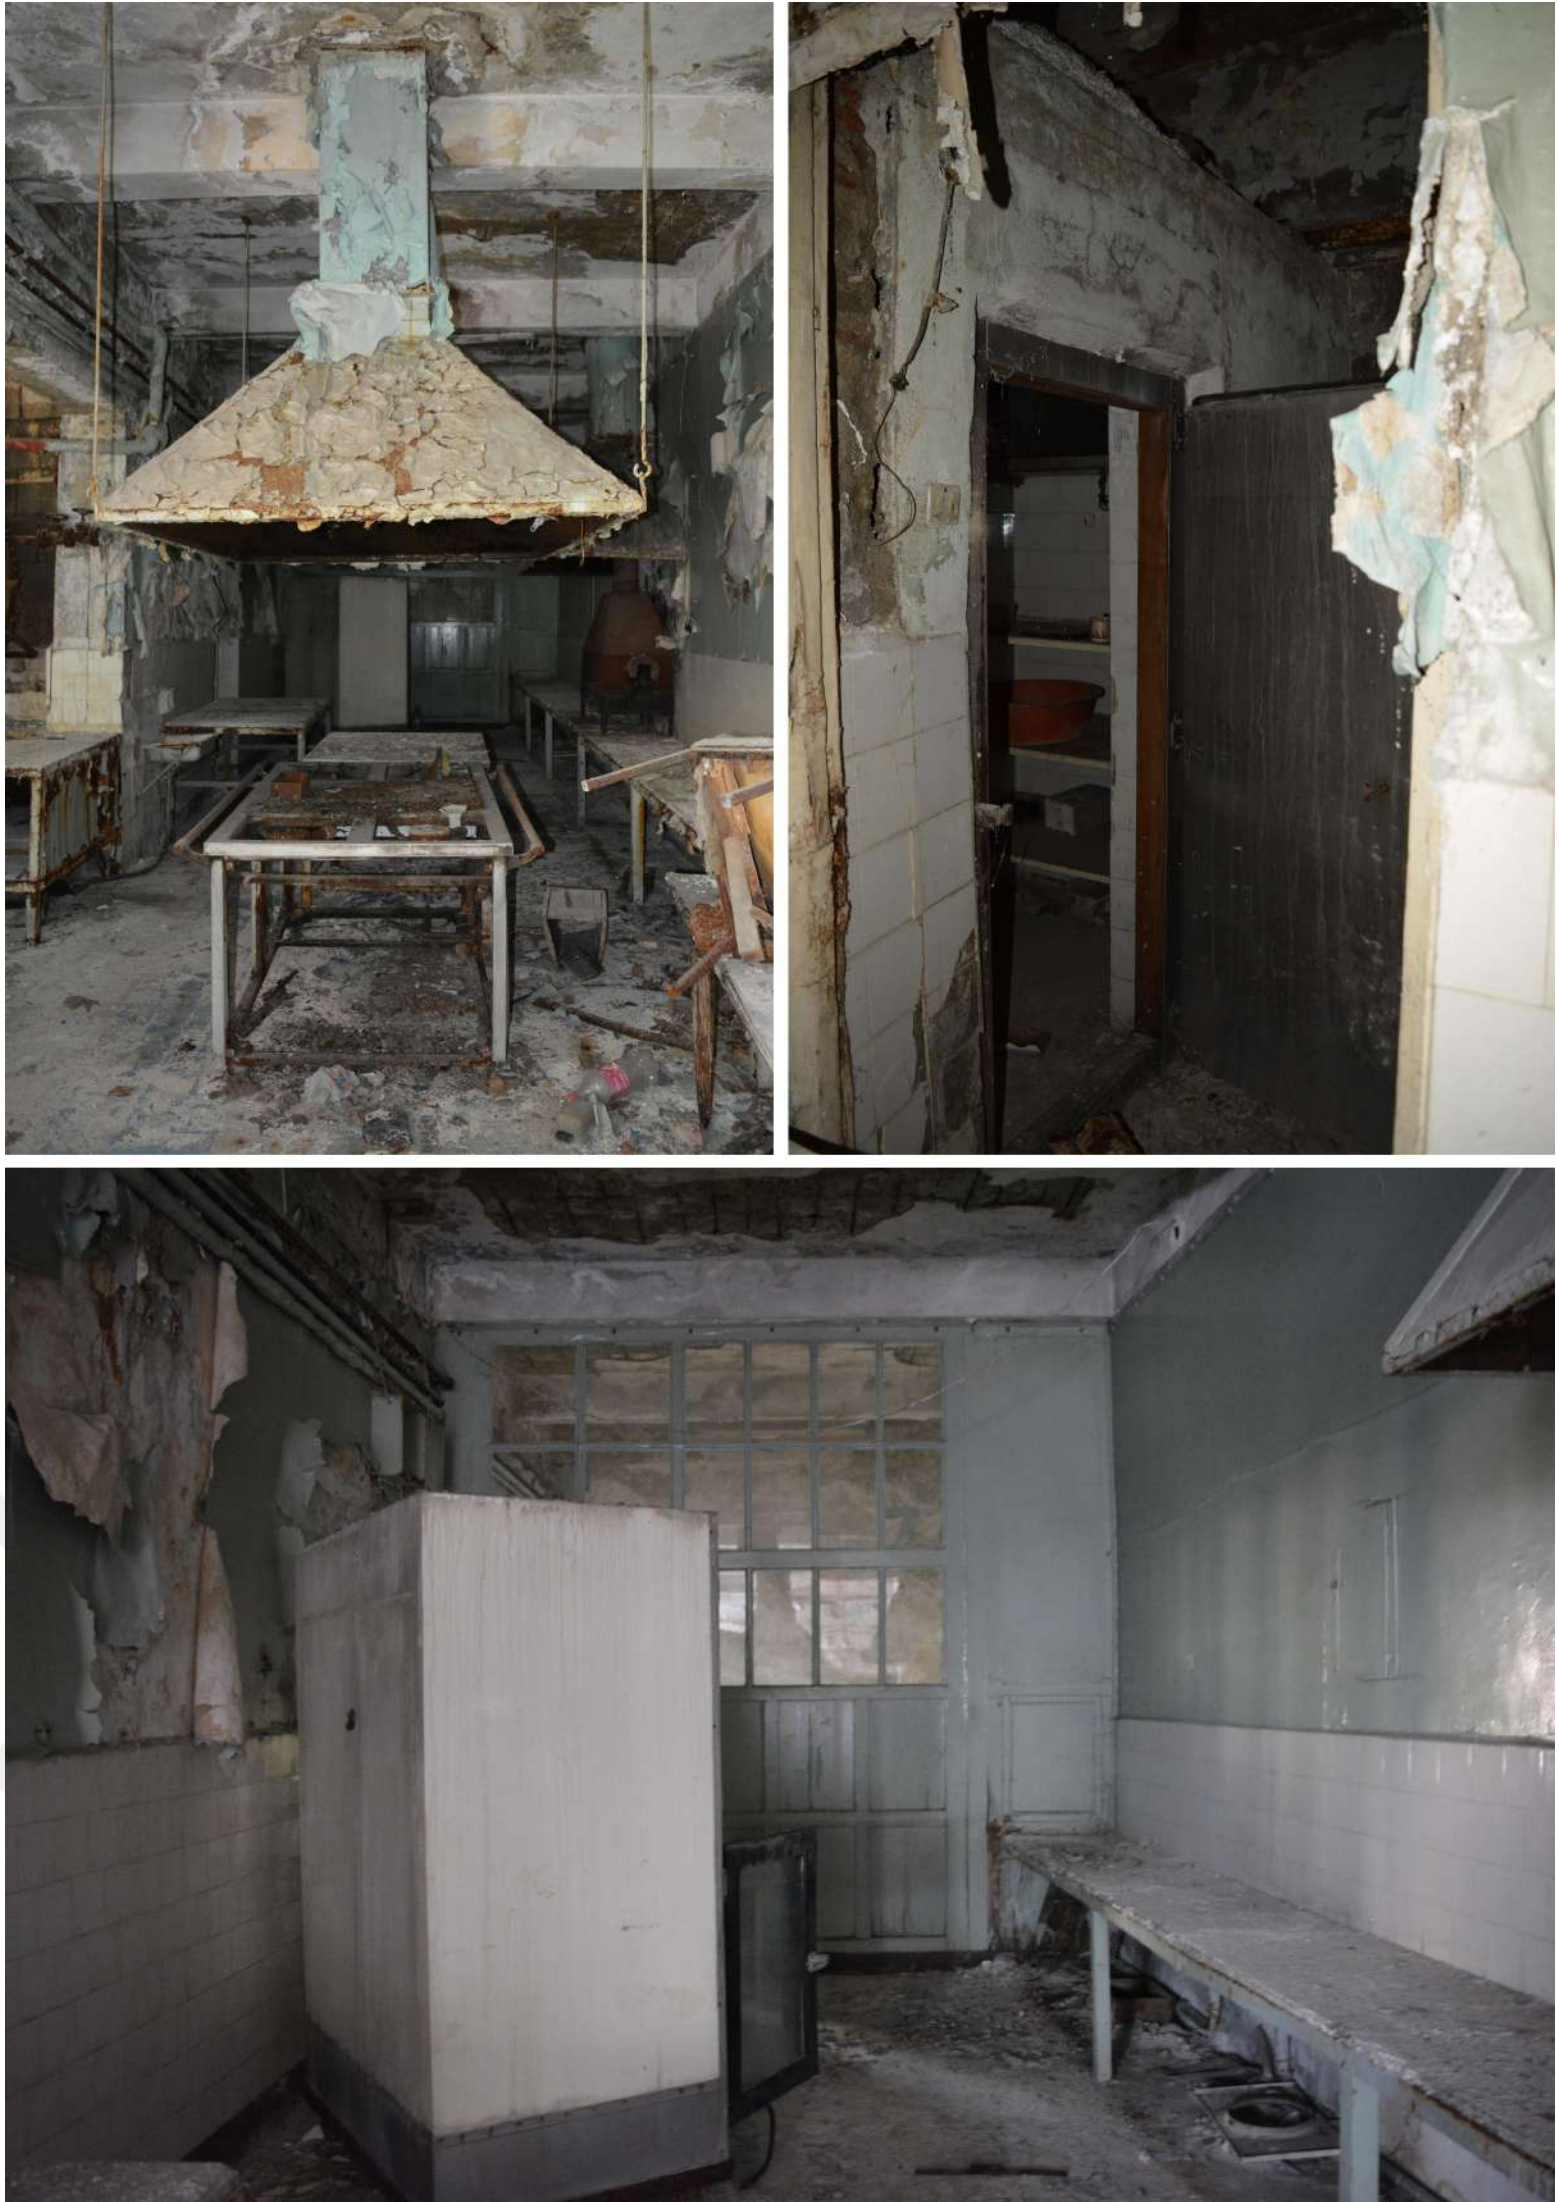
**Figure 4.12 G11 Kitchen**

The kitchen section (G11) of the building is one of the important places. It consists of a long rectangular space measuring 2.5m x 9.8m and a smaller space of 2m x 3.5m connected from the west to the long space. The height of the space is 3.7m. One of the entrance doors (D28) used as a service entrance is located in the west of the place. All the walls of the place are whitewashed, and ceramic covered. The floor is ceramic, and the ceiling is reinforced concrete. There is a 9.8m long bench on the east wall. This part has a barbecue area and a chimney outlet. The second chimney outlet is on the furnace in the middle of the area. There is a wooden separating wall and door in the north. (Figure 4.12)

A two-compartment cellar and a dish rack are located in the west. The cellar part has a separate door and there is also a room for the cold storage. A water unit is hung for hot water use in this area (Figure 4.11). There is a door in the south of the place, but the door leaf is missing. Reinforced concrete beams can be clearly read on the ceiling. The paint on the walls has been stripped. Particularly on the western wall, material loss is observed. There is damage to both the walls and the ceiling due to the water leaks

from the roof. Iron reinforcements were exposed on the ceiling, and these are corroded.<sup>15</sup>

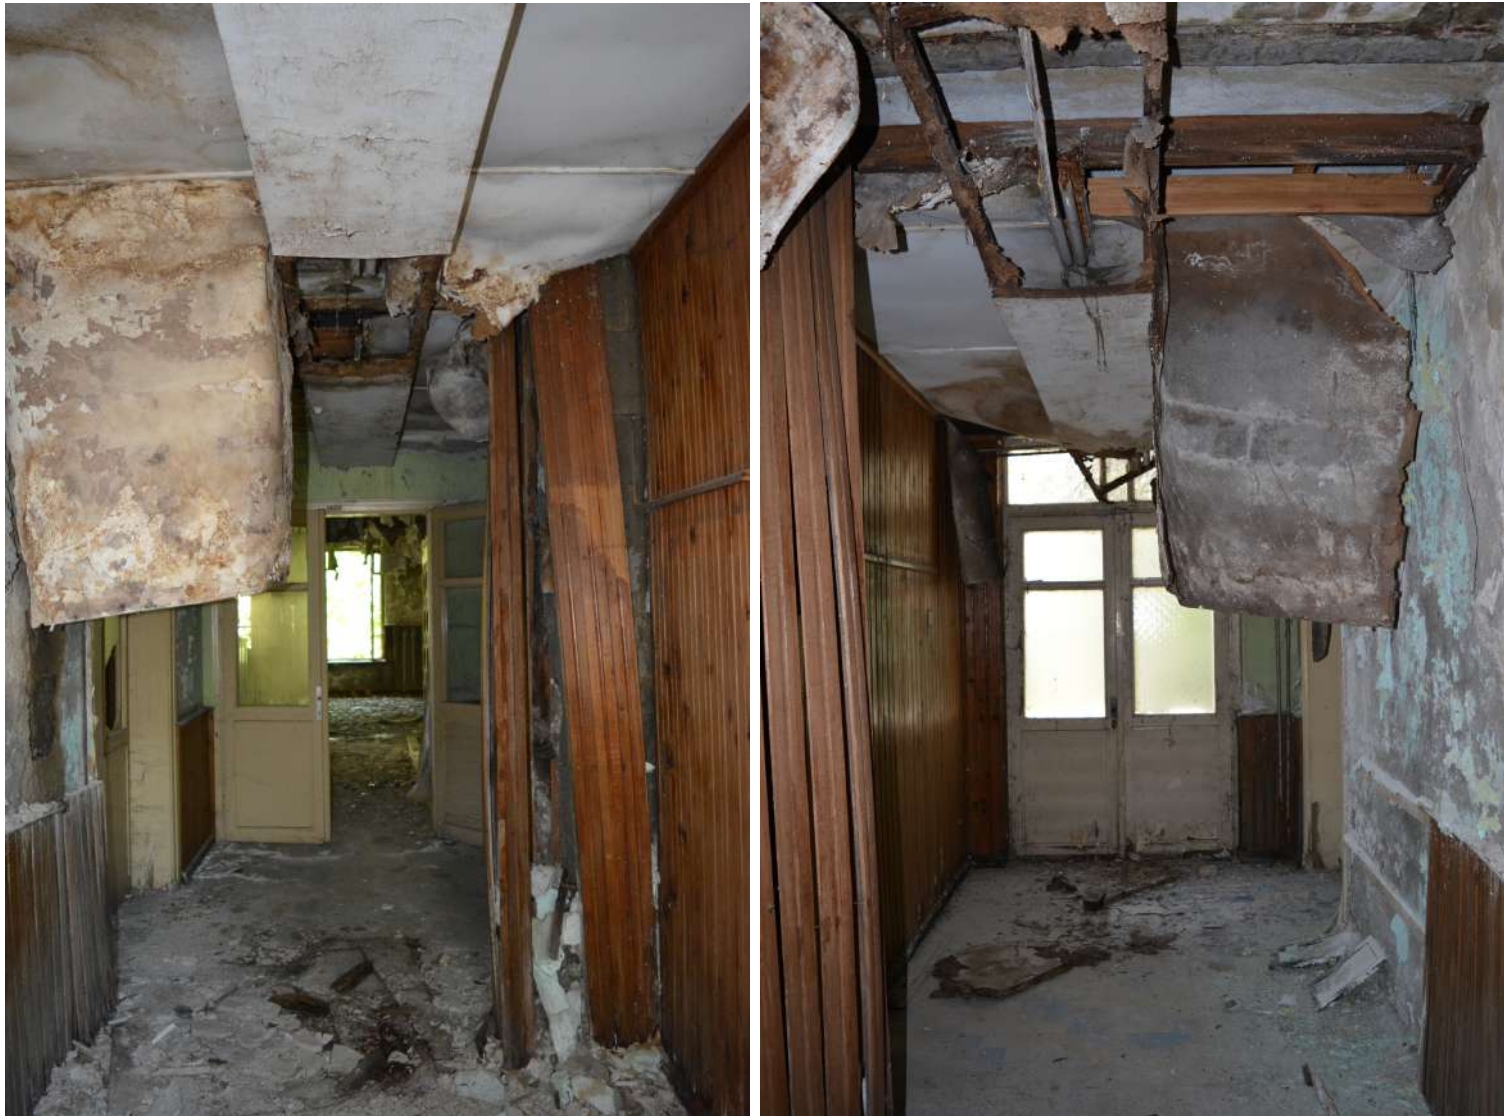
**Figure 4.13 G12 space**

The club entrance of the building is in the south where the transition space (G12) is located (Figure 4.13). It connects the user to the club from two different points. The east wall is the blind wall. There is a door in the north and two doors in the west. The western wall is completely wooden paneled. Other walls are plastered, whitewashed, and covered with wainscot approximately 1.5 m high. The ceiling is covered with wooden panels. Some of the wood on the wall and ceiling was destroyed.

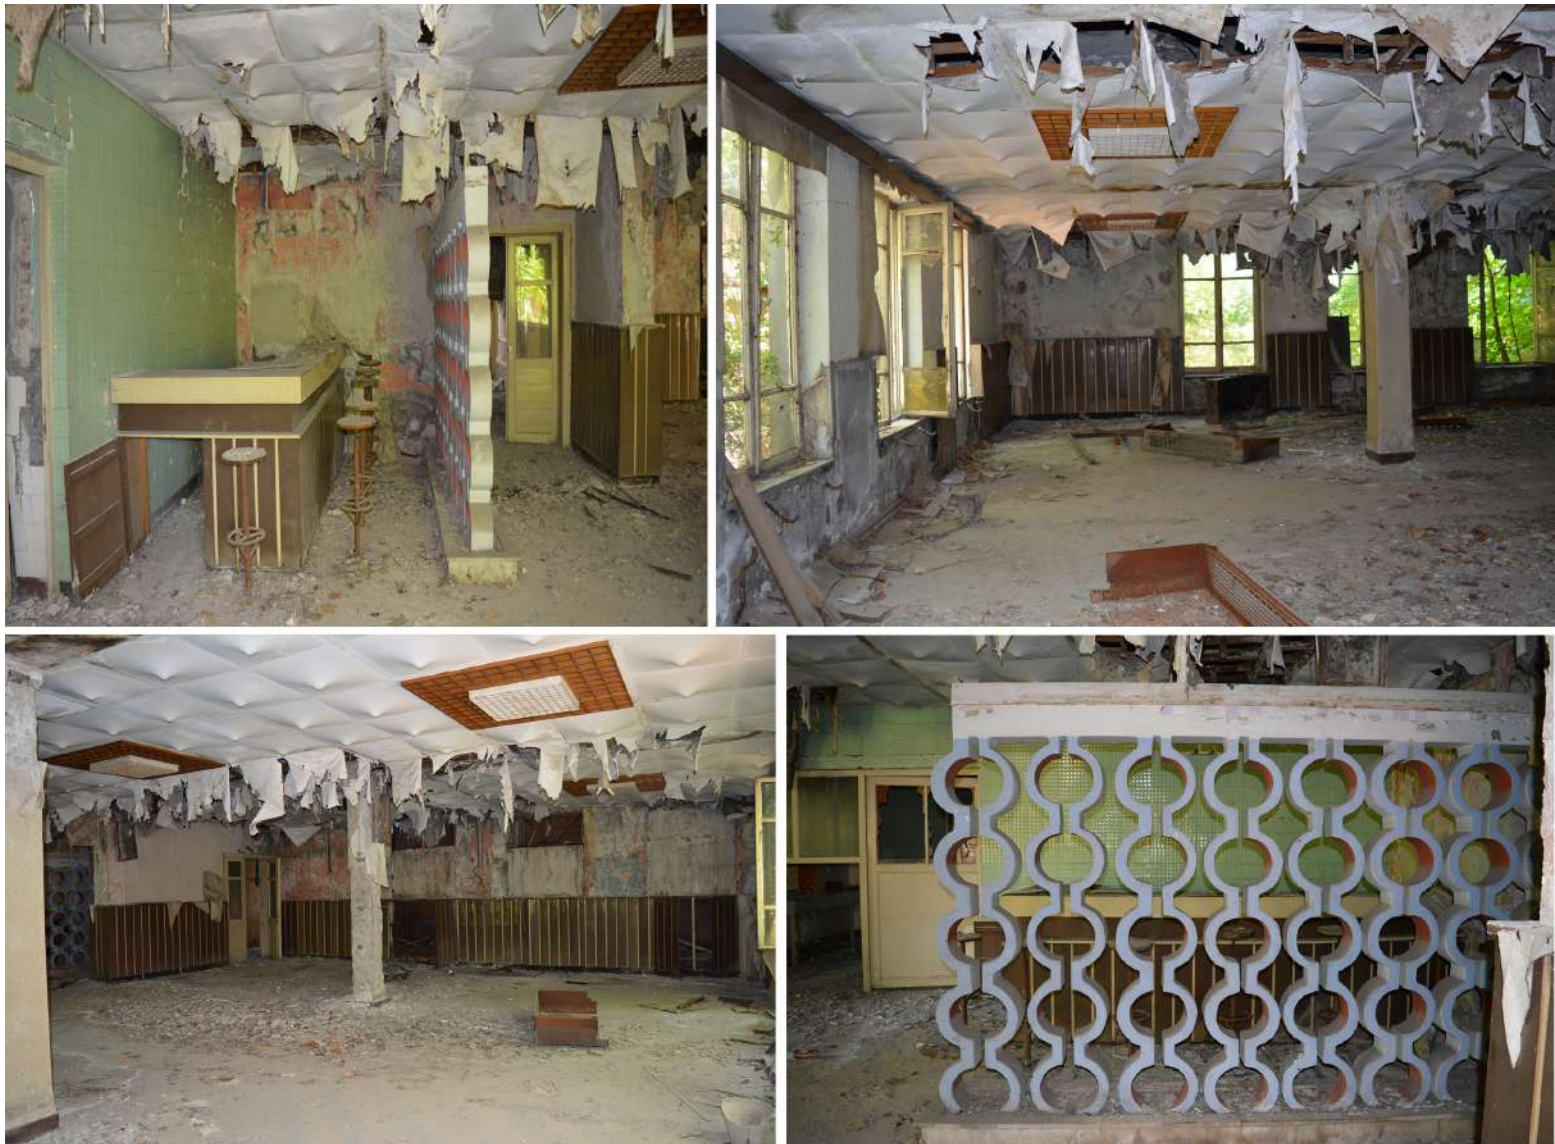
**Figure 4.14 G13 club**

There are two doors opening to the service areas in the east of the place. Further south, there is a concrete separation element that divides the space as a bar and dining area, reflecting the modern influences of the period (Figure 4.14). The east wall is completely covered with ceramics. There are four windows at equal intervals on the north and west walls. The south wall of the place was closed later and now there are cabinets. There is a 1.2m high paneling floor on the north, west, and south walls of the place.

Material loss and axis slippage were observed in the columns. Especially on the south wall, the damage is slightly higher because of the moisture and material loss. Ceramic flooring is not readable due to spilled debris.<sup>16</sup>

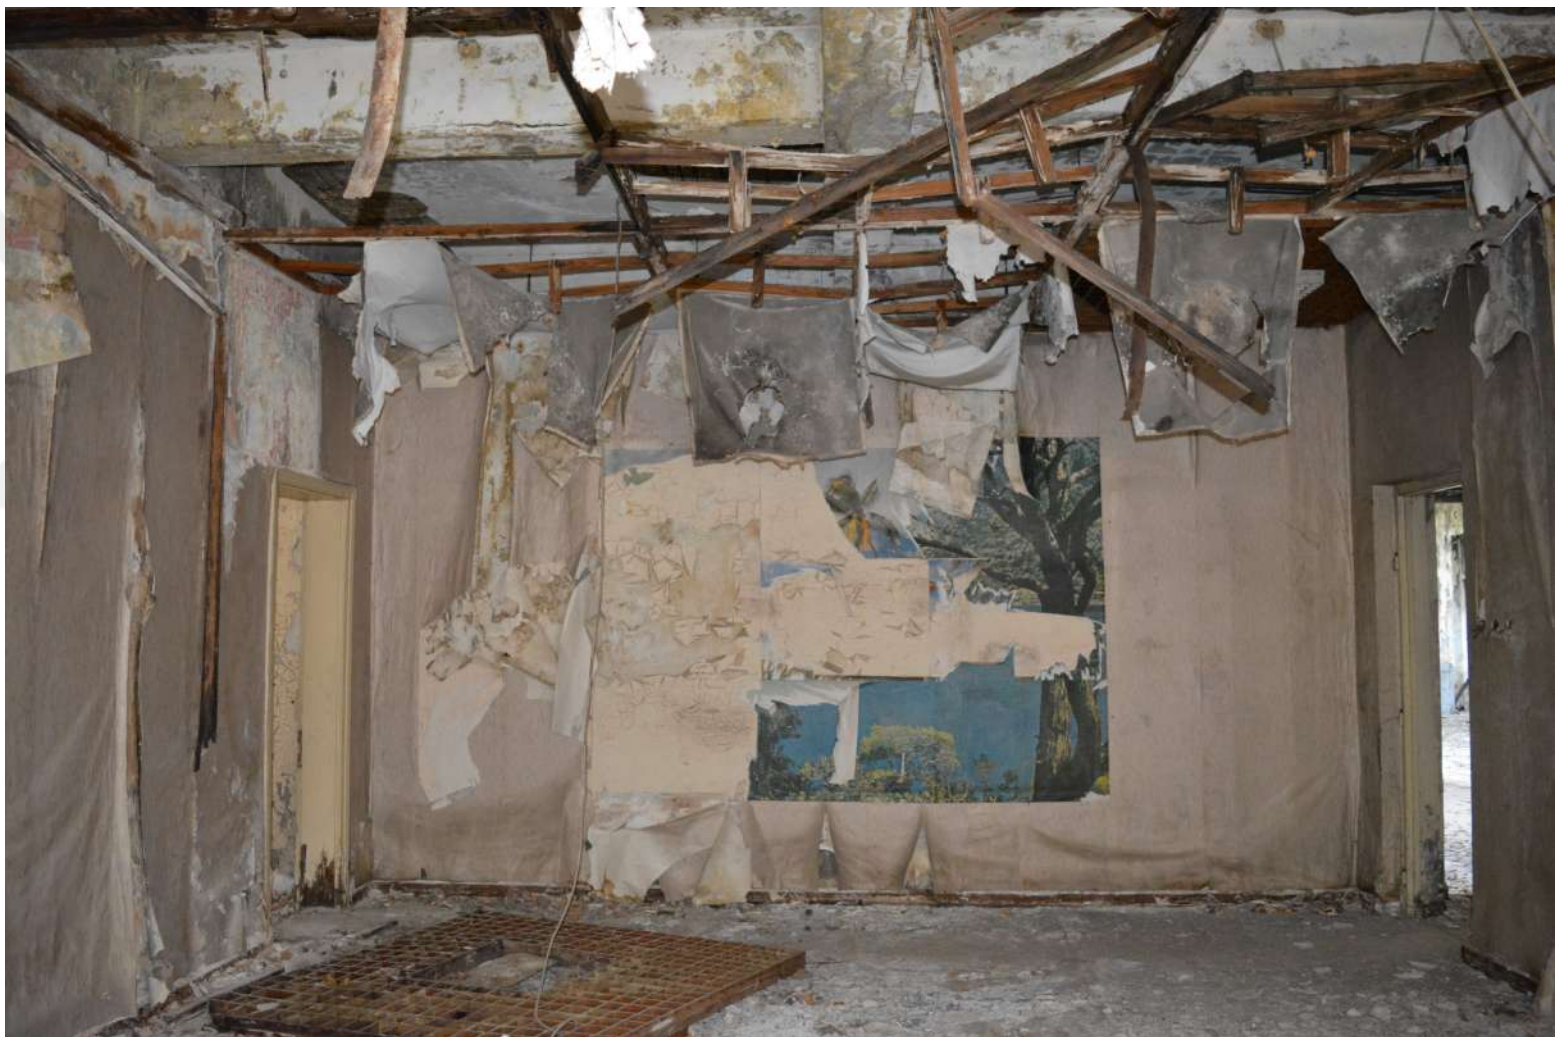
**Figure 4.18 G17 space**

The dining hall (G17) is located southern part of the building (Figure 4.18). There is the same blue and white ceramic on the floor, but they are covered with carpet. The walls have wallpaper. A wooden suspended ceiling is used on the ceiling. There is a door in the east of the space, but the door leaf is not in place. The northern wall is a blind wall. To the west, there is a wooden door and to the south, there are two wooden windows.<sup>17</sup>

The whitewash on the walls of this place has been removed. The suspended ceiling is damaged and disjointed. The reinforced concrete in the ceiling was corroded by moisture and the reinforcements were exposed. Because of those reasons, the floor is completely covered with rubble.

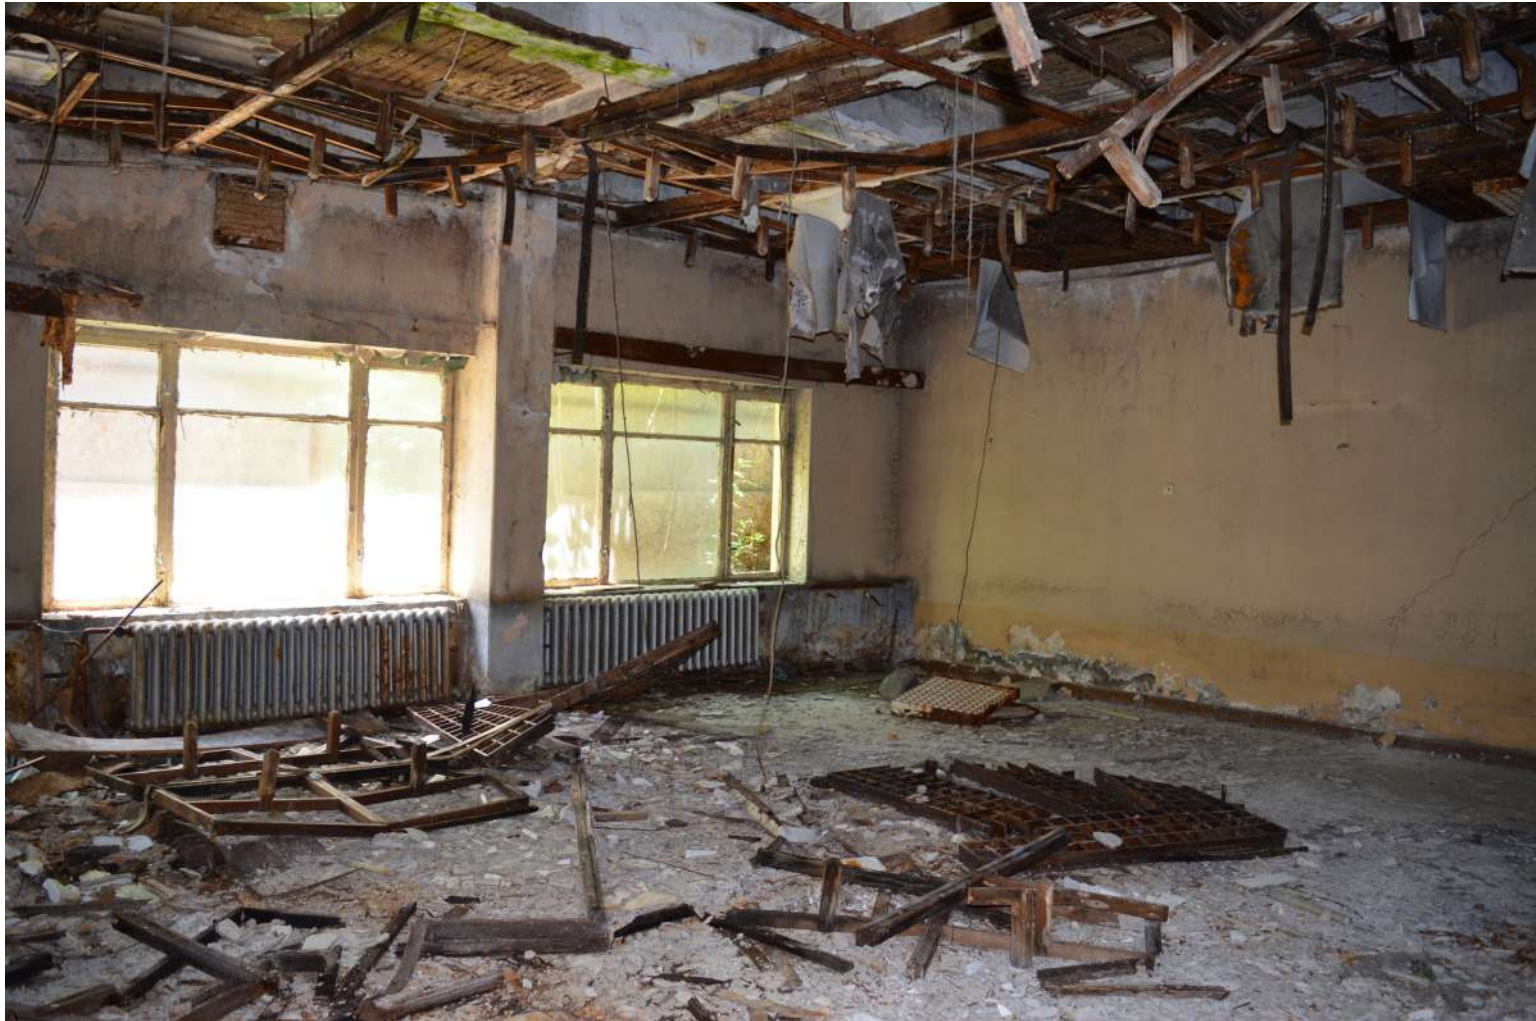
**Figure 4.20 G19 space**

The resting room (G19) to the east of the dining hall measures approximately 7.5m x 8m. The floor is ceramic tiled and carpeted on it, the walls are whitewashed and painted. The wooden suspended ceiling is used on the ceiling. The east and north walls of the place are blind walls. There is a door opening on the west, but the door leaf is not in place. There are two windows and one divided window to the south (Figure 4.20). The reason why it is divided is that the toilet and cloakroom in the entrance corridor (G18) were added later (Figure 4.19), the wall coincided with the window in the G19 space. There are also heater cores under the windows.

The space leaks water from the roof. For this reason, damages such as corrosion of reinforcements and vegetation were observed on the ceiling. At the same time, most of the wooden suspended ceiling was damaged. Its floor is covered with rubble due to elements pouring from the ceiling.

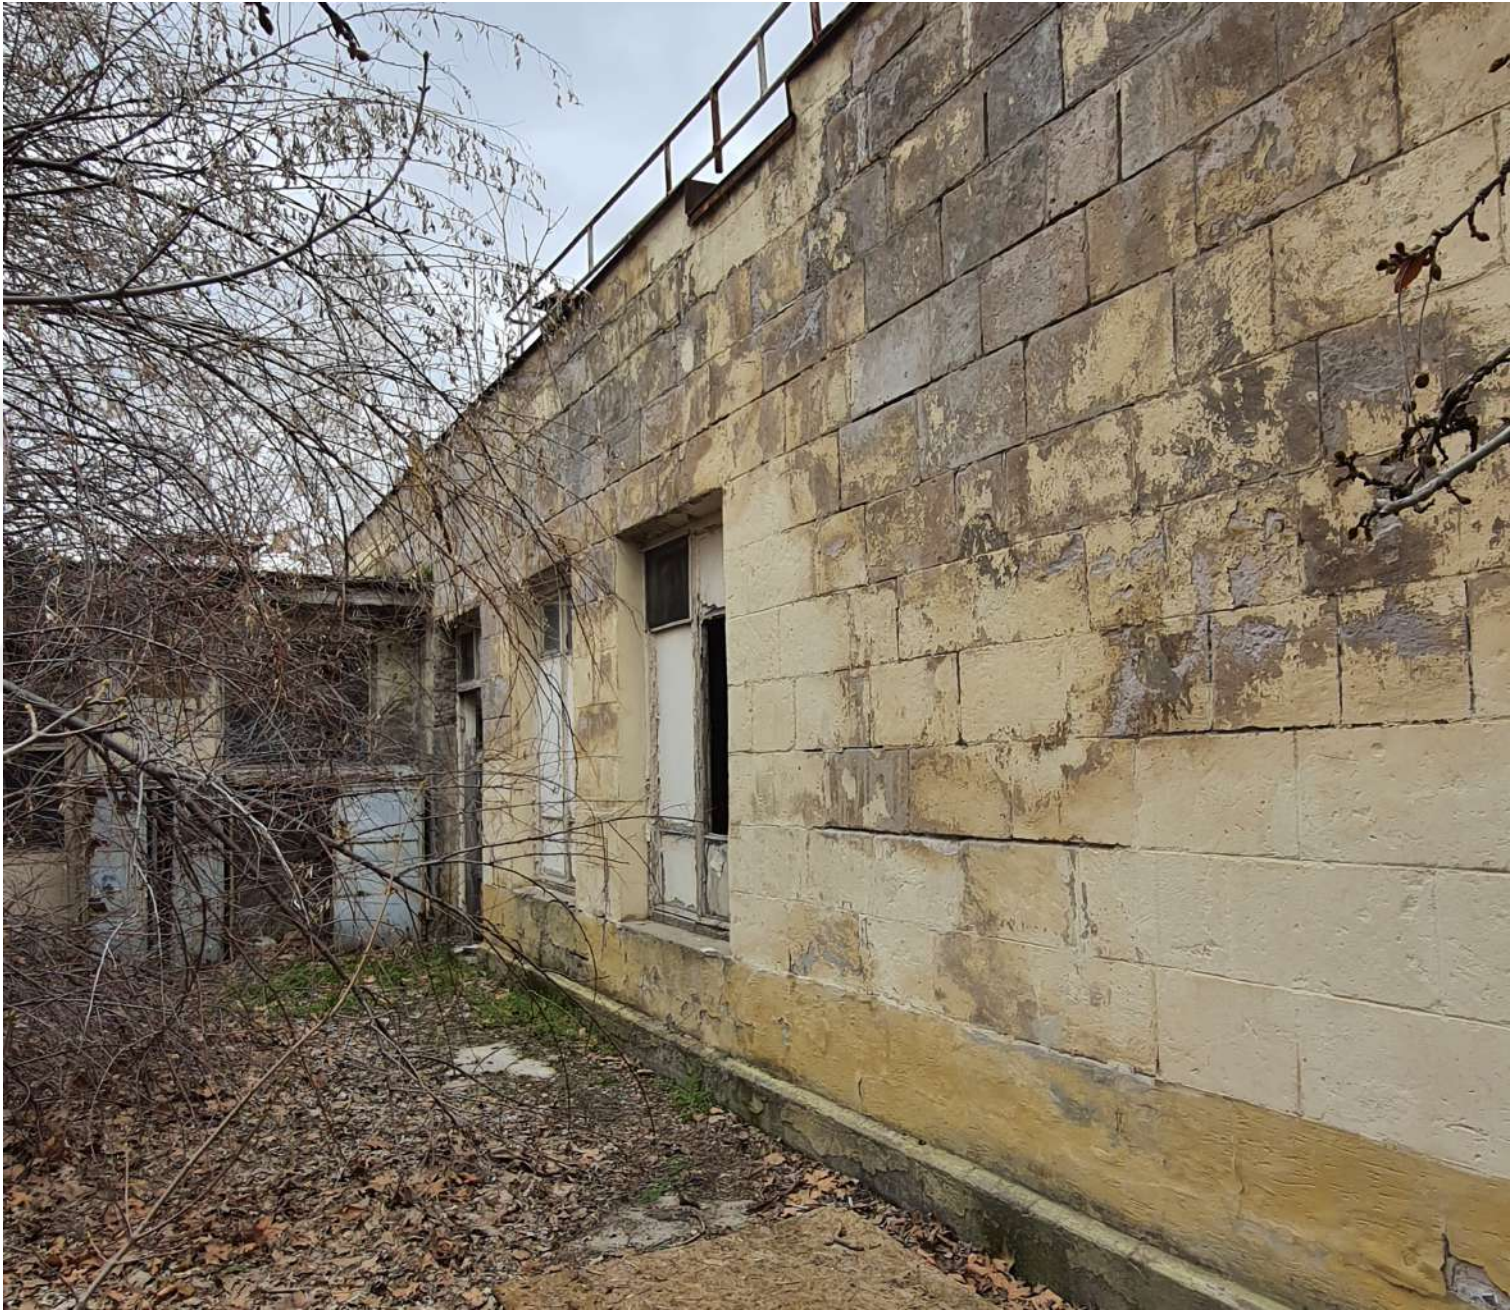
All the façade elements are cladding stones. On the other hand, the northern and southern ends of the protruding section were added later and are plaster with a stone look. The southern section of the façade ends with an iron railing 50cm high (Figure 4.26). In particular, there are trees adjacent to the façade. The roots of these trees have damaged the façade stones.

**Figure 4.26 View of the southern section of the western façade**

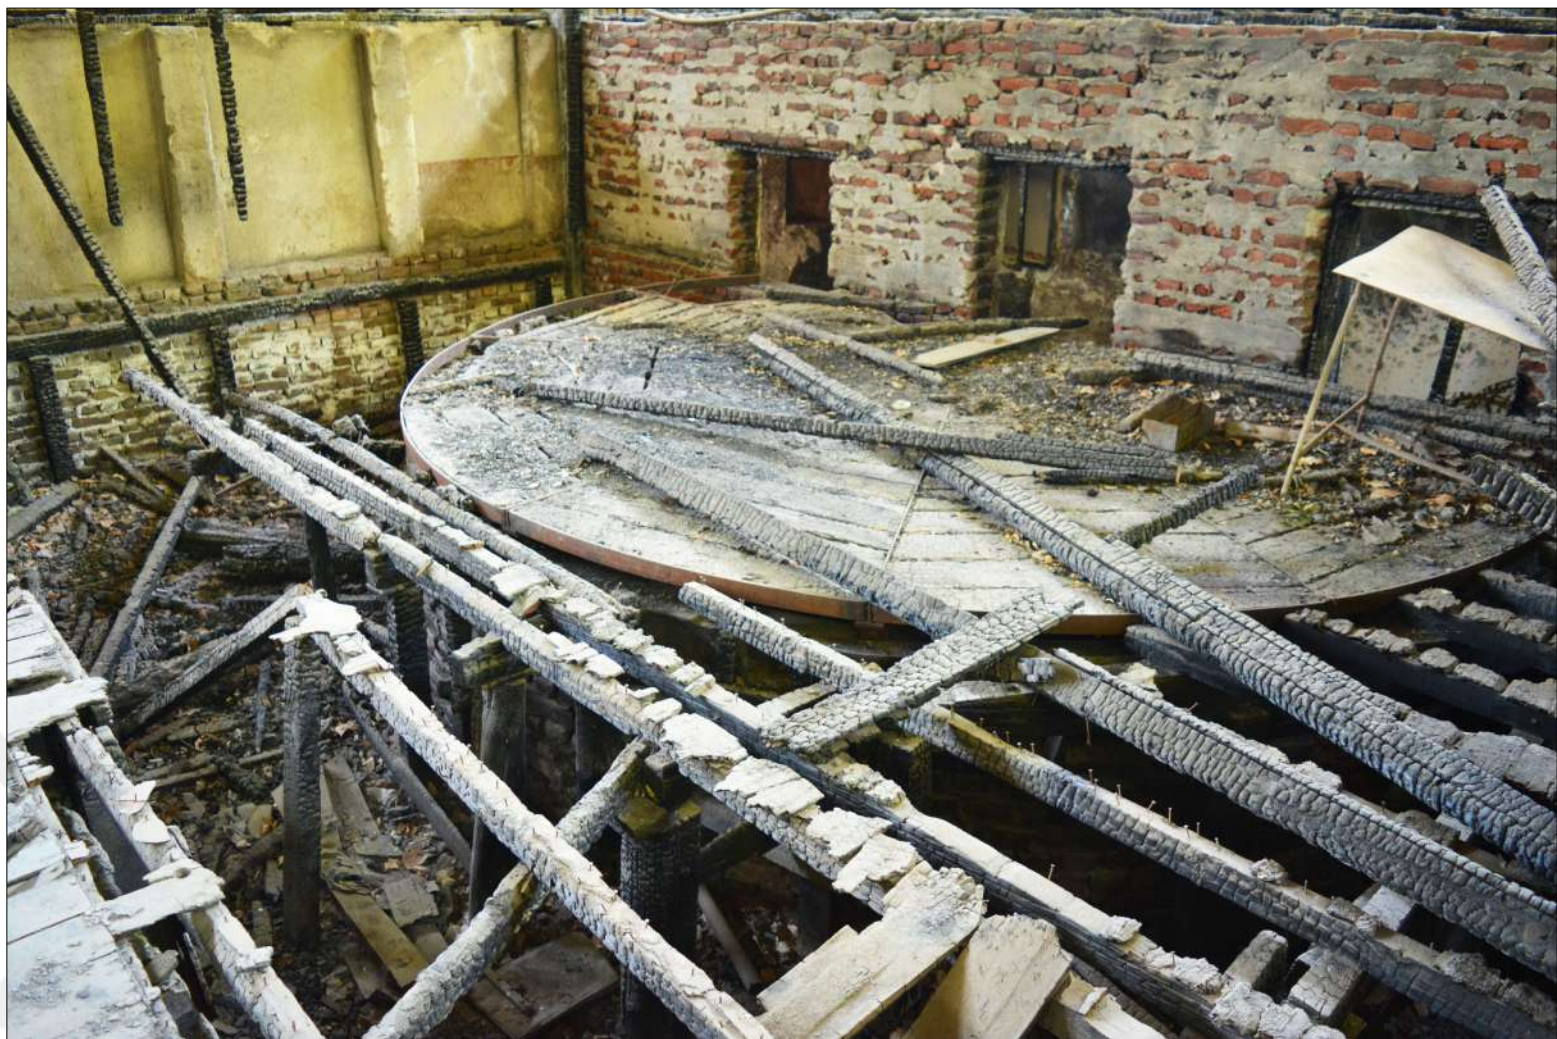
**Figure 4.32 G02 Scene**

The stage part in G02 space is a very significant detail for the building (Figure 4.32). Cinema, theater plays, various dinner organizations took place in this part. Since it is the area most affected by the fire, the level of destruction is high. The center of the stage is designed in the form of a semicircle. The circle frame settles on its floor as a brick wall. A metal frame is mounted on the concrete surface. The metals are divided into eight slices to converge at a point in the center. The stage surface was created by placing wooden elements between each slice. There is a square support element on the floor to support the stage surface where the exact size and material cannot be seen.

the western and eastern walls by horizontal wooden elements. However, since the wooden parts were burned in the fire, precise information could not be reached, especially in the western part.
