CONSERVATION OF MODERN  
ARCHITECTURAL HERITAGE: CASE  
STUDY OF SUMERBANK  
KAYSERI TEXTILE FACTORY  
EMPLOYEES' CLUB

A THESIS  
SUBMITTED TO THE DEPARTMENT OF ARCHITECTURE  
AND THE GRADUATE SCHOOL OF ENGINEERING AND  
SCIENCE OF ABDULLAH GUL UNIVERSITY  
IN PARTIAL FULFILLMENT OF THE REQUIREMENTS  
FOR THE DEGREE OF  
MASTER OF SCIENCE

By  
İrem BAZ  
April 2023

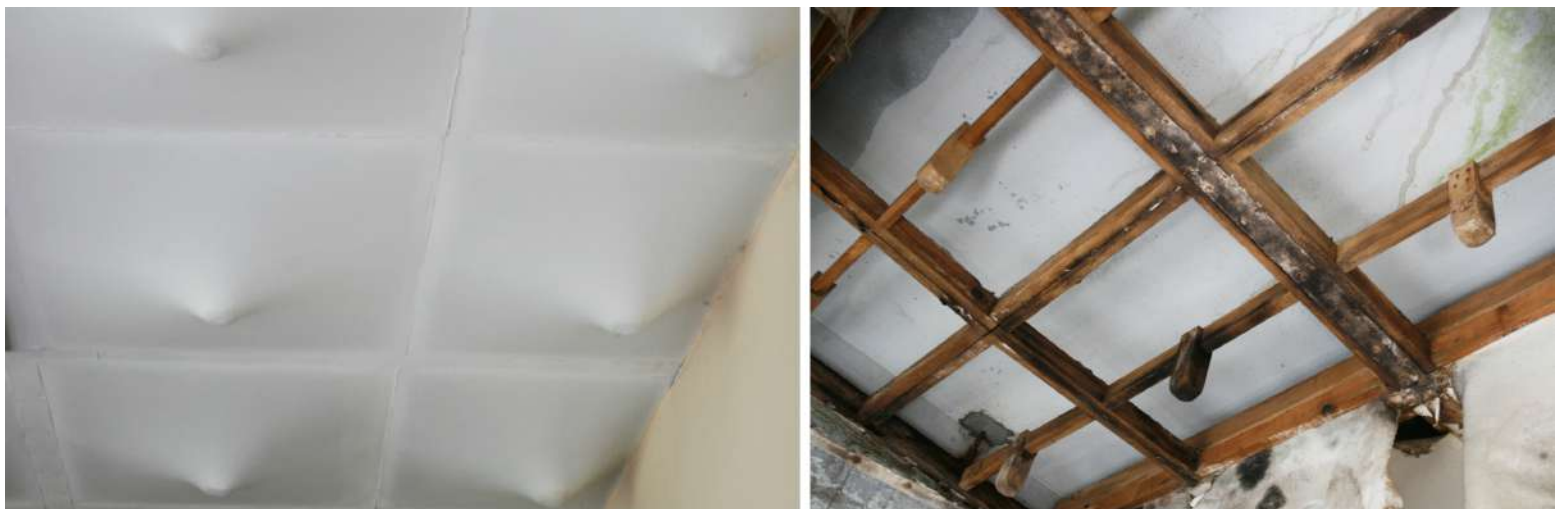
**Figure 4.33 Wooden suspended ceiling**

A wooden suspended ceiling is the most fascinating ceiling detail of the building. Drop-shaped modules hanging from the middle of the wooden frame were produced (Figure 4.33). Pieces of white textile were stretched over the wooden pieces. In this way, a suspended ceiling was formed by the juxtaposition of the modules. Modules in the square form are 65cm x 65cm and 88cm x 88cm, rectangular ones are

As the wood rots due to moisture, the suspended wooden ceiling has cracked in most places. It has been determined that the fabrics, which are a part of the suspended ceiling, are also damaged and torn from place to place.

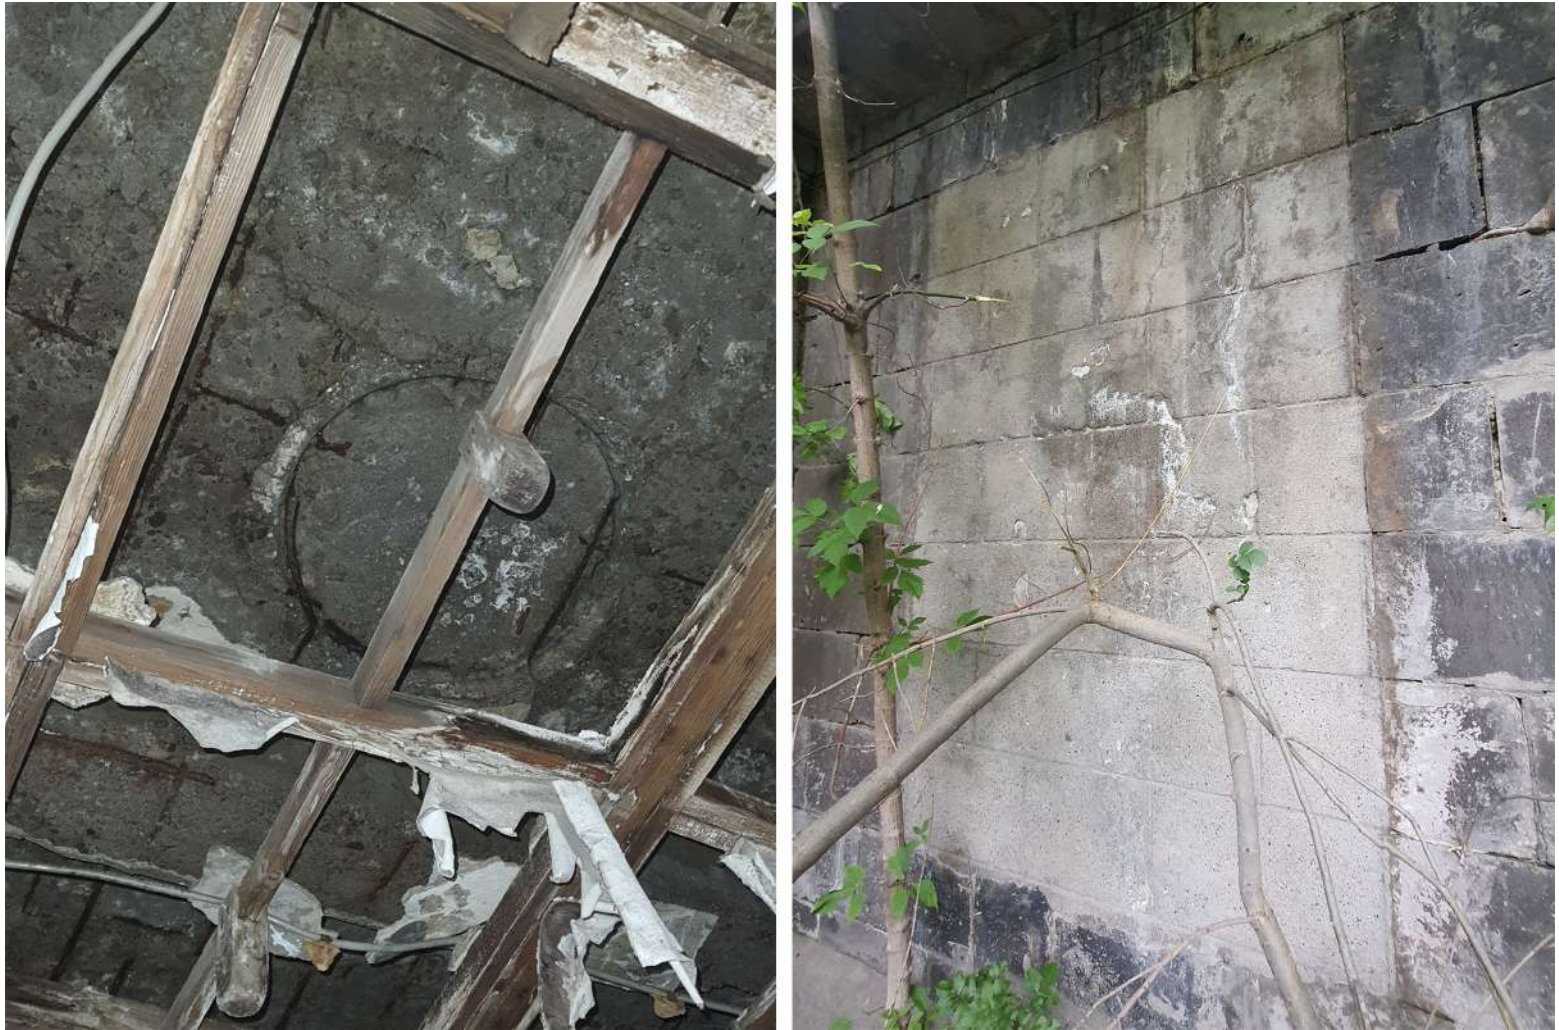
**Figure 5.1** Traces of the closed chimney in club section and opening on the northern facade

It is understood that the square form space to the west of the building was used as a kitchen. The traces on the building also support this. There is a trace of a former opening on the northern façade of this place. At the same time, it was determined that there was another trace of a closed chimney on the ceiling. As seen in the old drawings, the space was divided by the partition walls. There was a corridor between the kitchen and the cinema hall that was used for service purposes. There are also tea shop and toilets on this line.

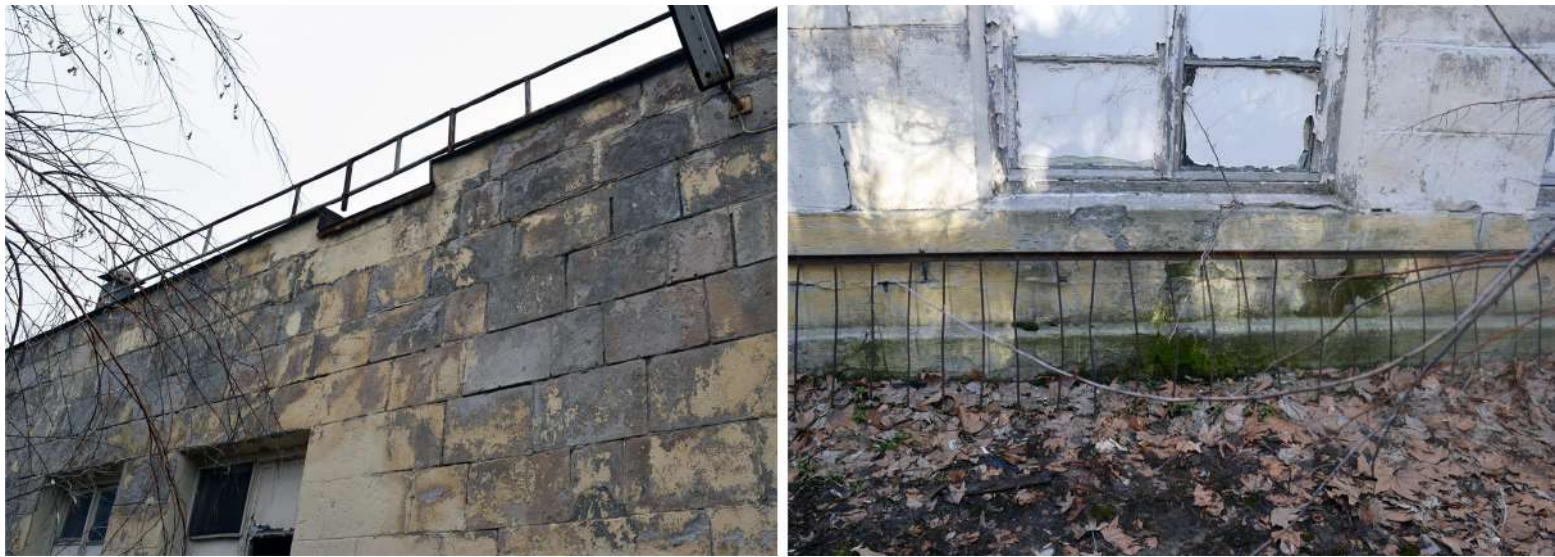
The technical unit for the movie screening, located on the upper floor in the south, is the most important part of the building that has not been answered. Although one of the plans includes a staircase providing access from the inside, there is no trace of it in the building (Figure A3). For this reason, it is considered that external access is provided. The presence of a suitable place in the building on the west façade and an iron staircase in the garden support this (Figure 5.4). However, it can be said that this access does not make much sense in winter times.

**Figure 5.4** Traces of the access to the upper level

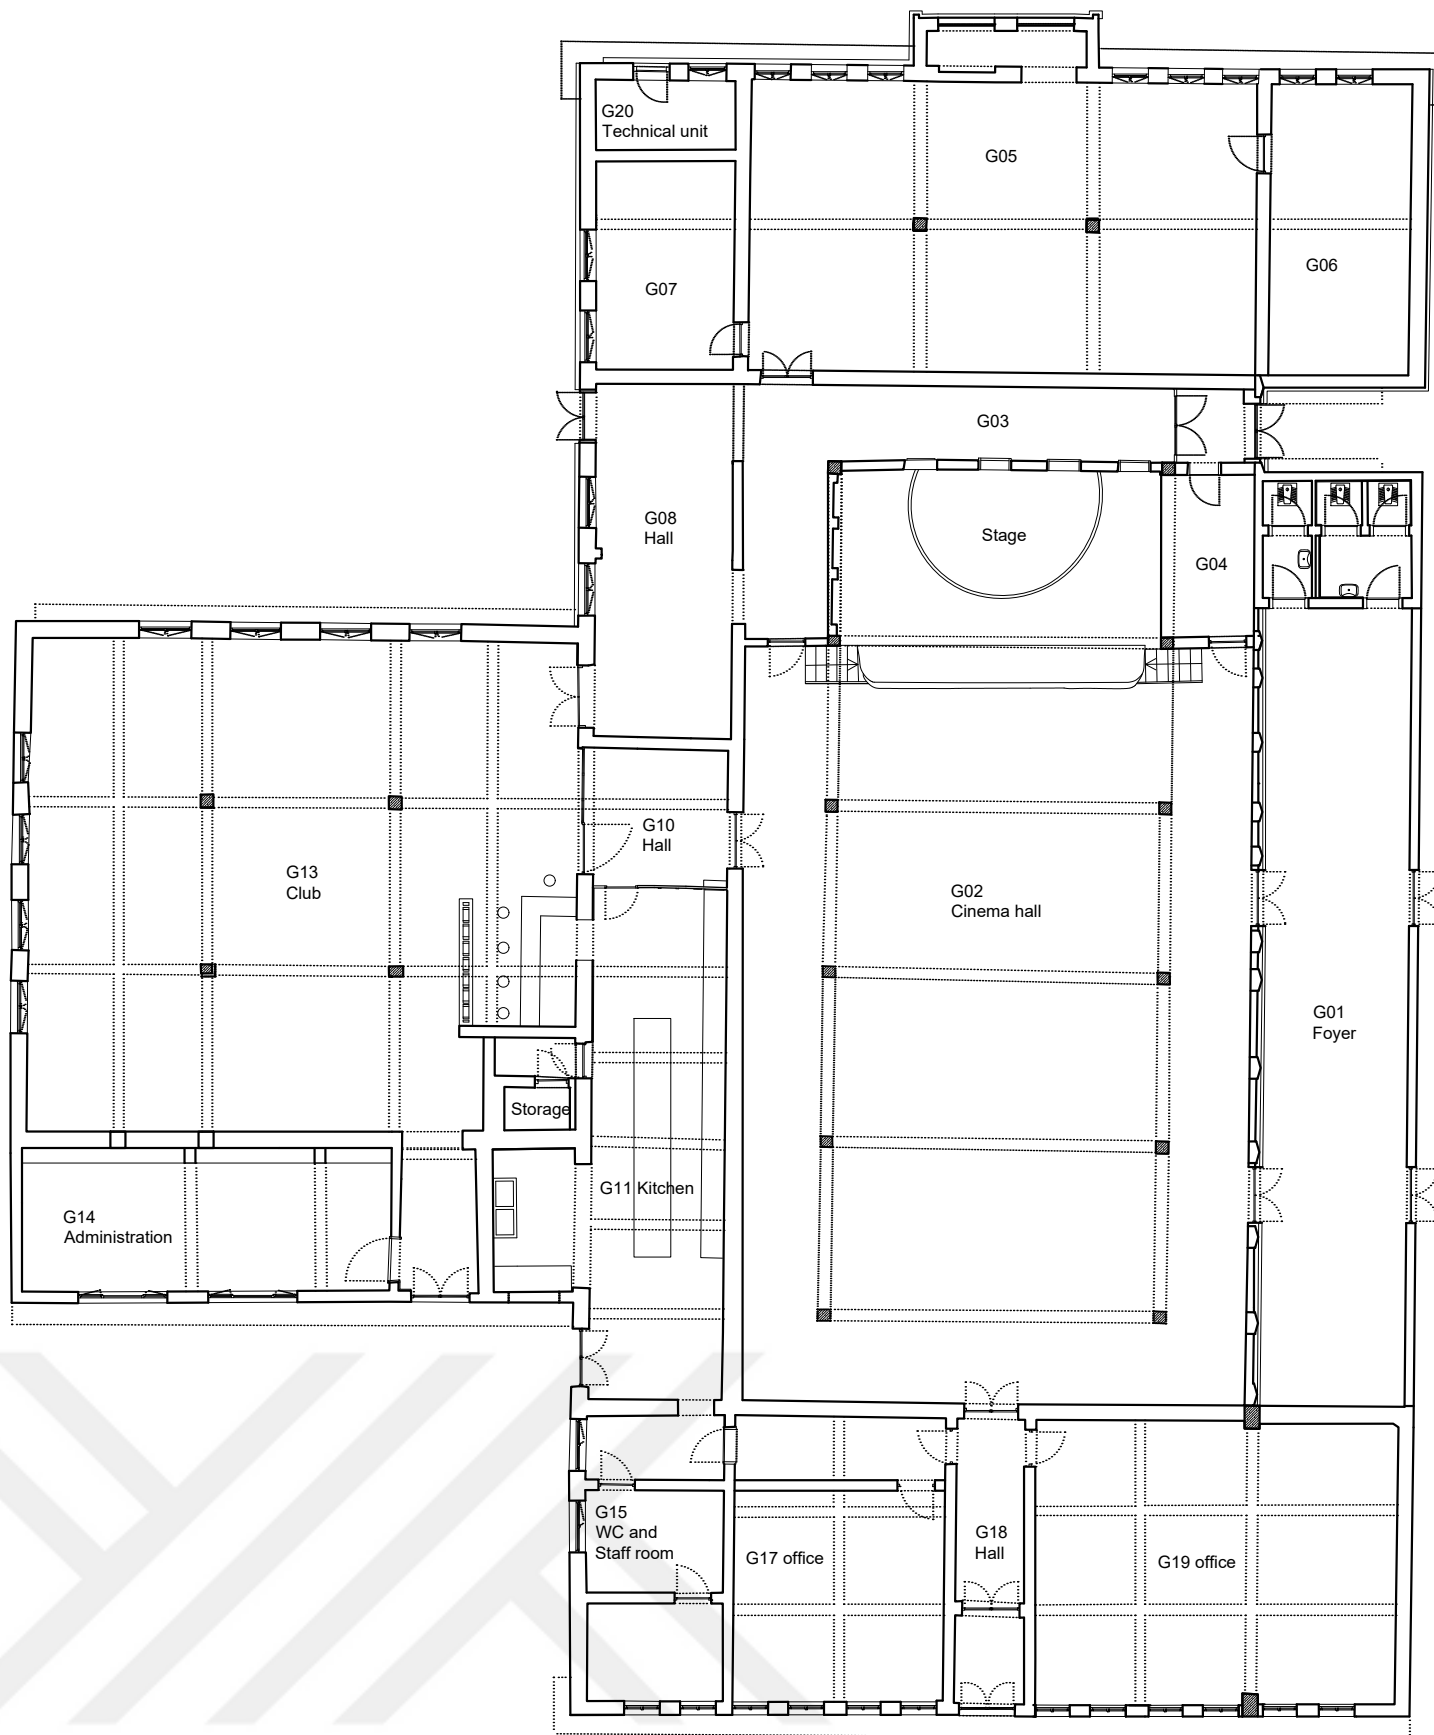
**Figure 6.1 Reuse proposal for the Employees' Club**

The fact that the function of the building in the factory period included a social purpose was the first point that was taken into consideration. It is thought to give a mixed function that reflects its original identity and characteristics and prioritizes the current needs of the university. Within the building, functions such as a multi-purpose hall, foyer, and club where various events and workshops can be held by the students and university staff have been proposed (Figure 6.1).

The backstage organization will be more alive. Since the western façade of the building faces the part of the campus where the offices and cafe are located, it was considered to provide an entrance from this façade as well. By creating an axis with the existing eastern entrance, it will be possible to access the backstage and club sections from this door. In this case, the place where the toilets, referred to as G08, are located will also be removed. This area will be left as a hall and a comfortable transition area will be created (Figure 6.1).

renewed, they will be preserved in the same places. In order to establish a relationship with the bar section in the west, it was thought to include a service window between these spaces. Since G15 and G16 spaces are related to both the kitchen, G17 and G18 spaces to the south, these are thought to have a toilet, staff room, and storage functions (Figure 6.1).

It is suggested that the south entrance of the building should be preserved in the same way. Since the south façade looks an unactive area, it is thought that this entrance will mostly serve the employees. It is planned to remove the toilet and cloakroom section in G18, which were added later, and add the space to G19 as a single volume. It is recommended that spaces G17 and G19 be used as offices. Different collaborators can work together as the club building has a social and multi-purpose function in general. For this reason, new programs and activities can be organized by using these offices from time to time.

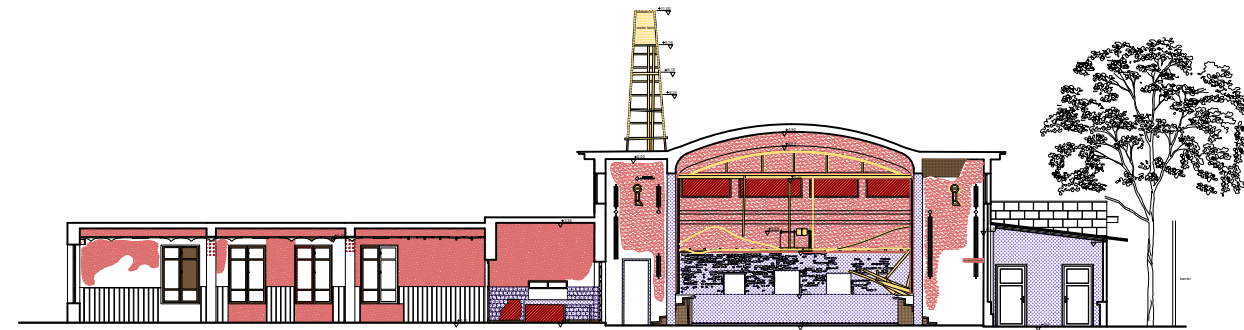
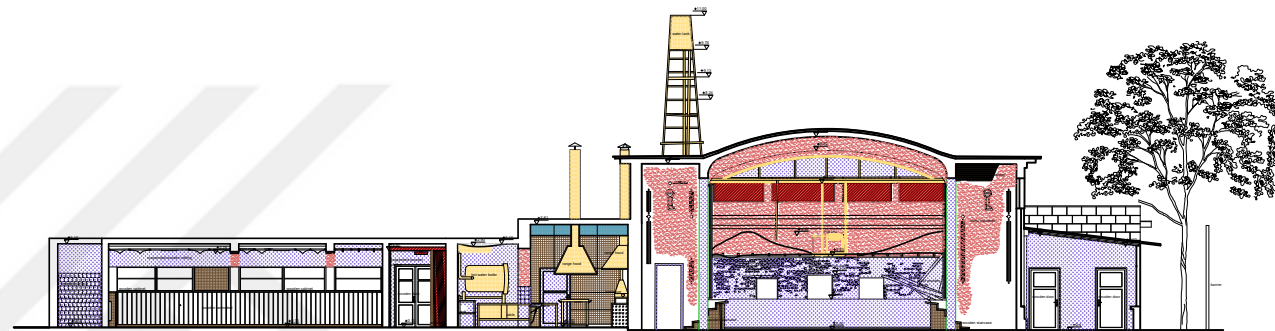
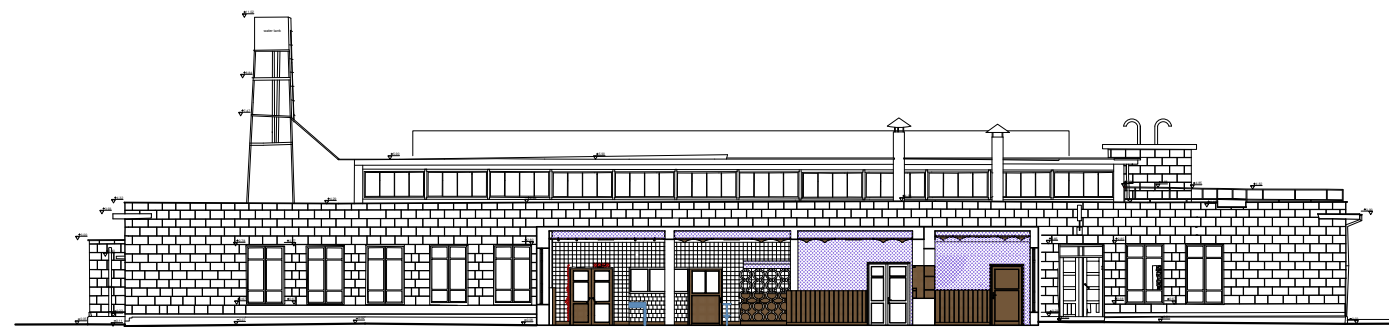
Drawing C18 Deterioration analyses of sections

- Crack
- Inclination
- Loss of architectural element
- Wooden material exposed to fire
- Rust stain
- Surface deposit
- Deteriorated plaster
- Deteriorated timber element
- Crystallization of salts
- Botanical decay

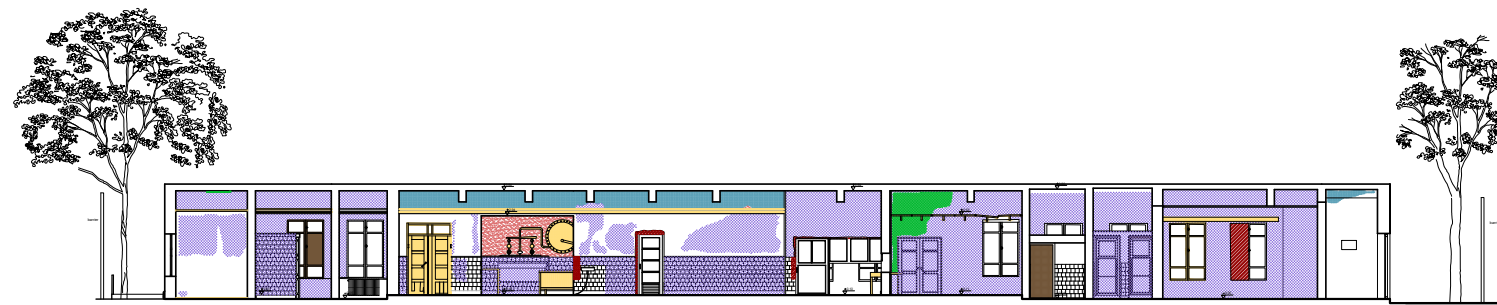
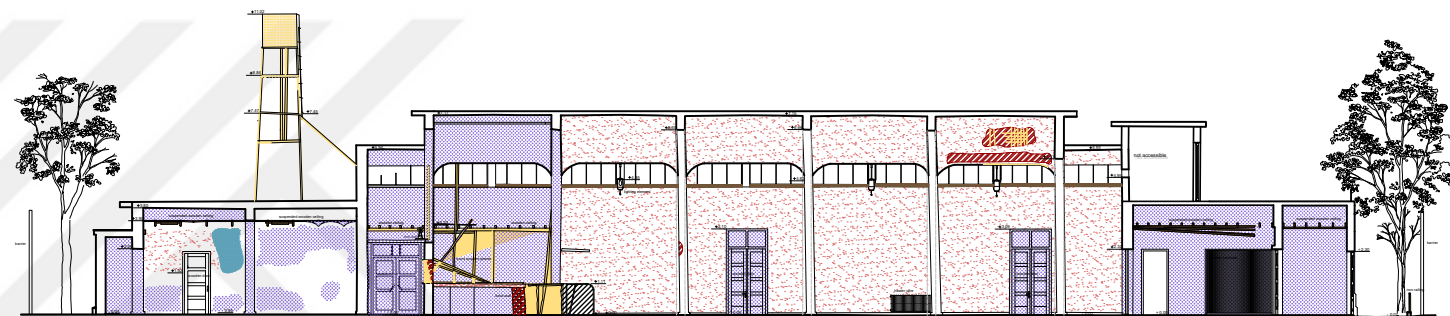
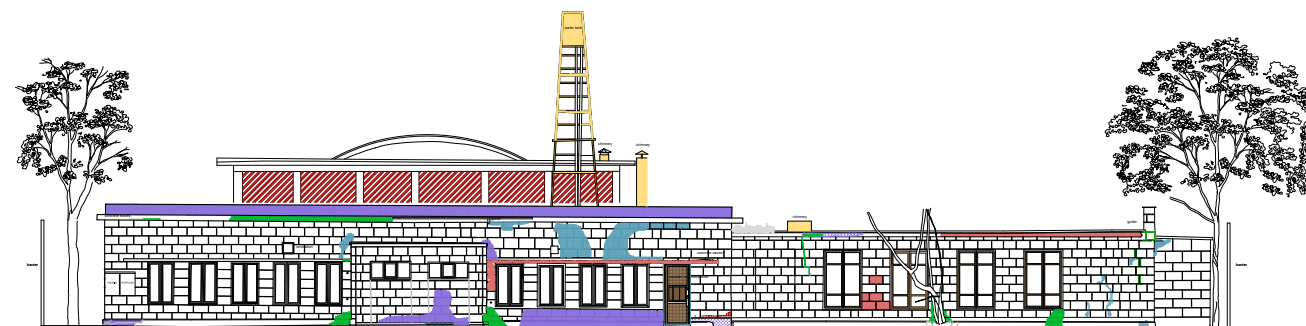
Drawing C19 Deterioration analyses of sections and elevation

- Crack
- Inclination
- Loss of architectural element
- Wooden material exposed to fire
- Rust stain
- Surface deposit
- Deteriorated plaster
- Deteriorated timber element
- Crystallization of salts
- Botanical decay
